WORLD METEOROLOGICAL ORGANIZATION

NEW DEVELOPMENTS IN AERONAUTICAL METEOROLOGY

Windshear and Turbulence Detection and Warning At Hong Kong International Airport

(Submitted by S.Y. Lau, Hong Kong Observatory)

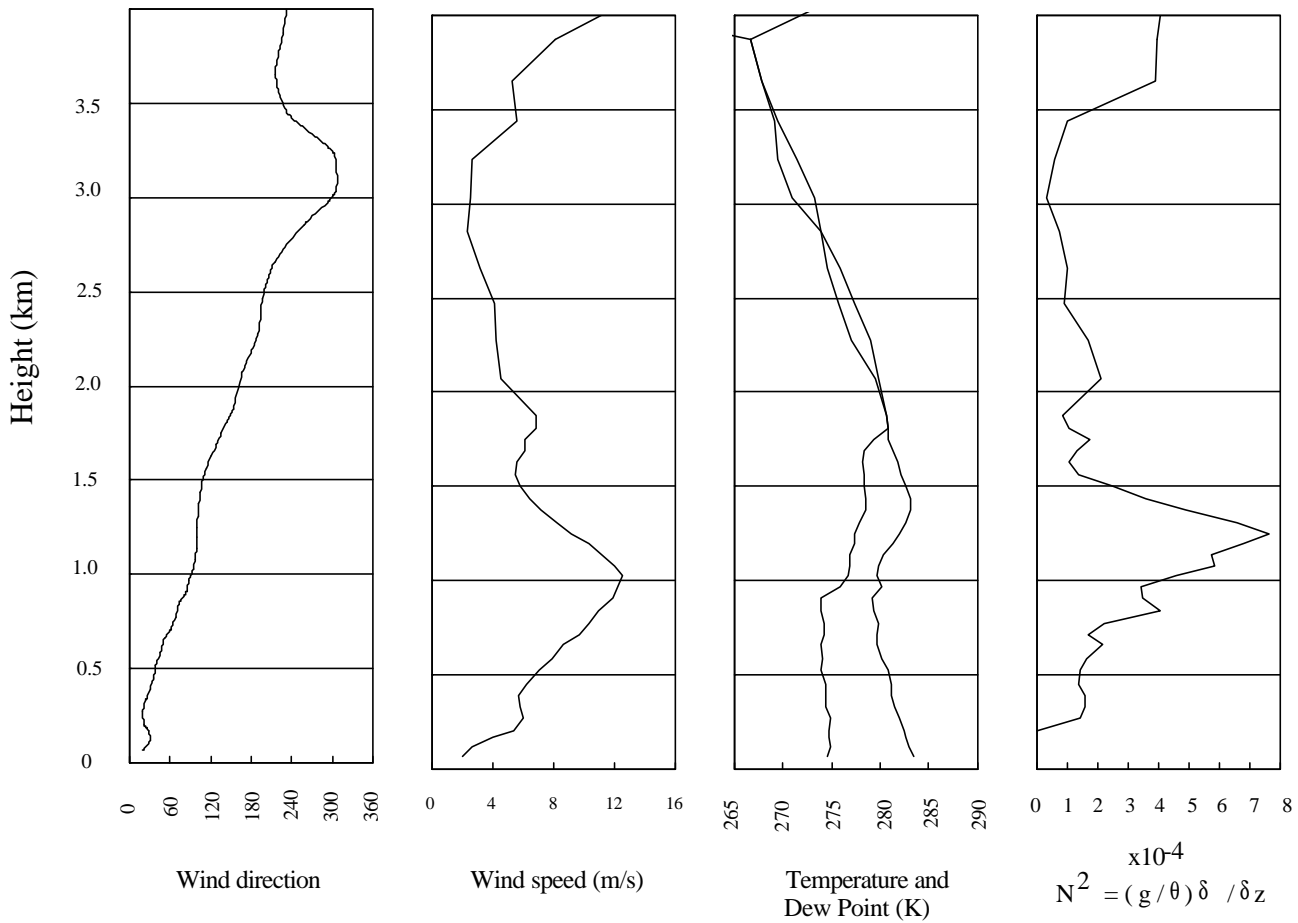
Figure 6 Variation of wind direction, speed, temperature, dew point and N^2 based on the King's Park radiosonde ascent valid at 00Z 31 January 2000

4.2 A recent example of significant windshear caused by low-level jet is 31 January 2000. A replenishment of the winter monsoon reached southern China on 30 January 2000. The weather became cloudy with light rain the next day. Figures 5 and 6

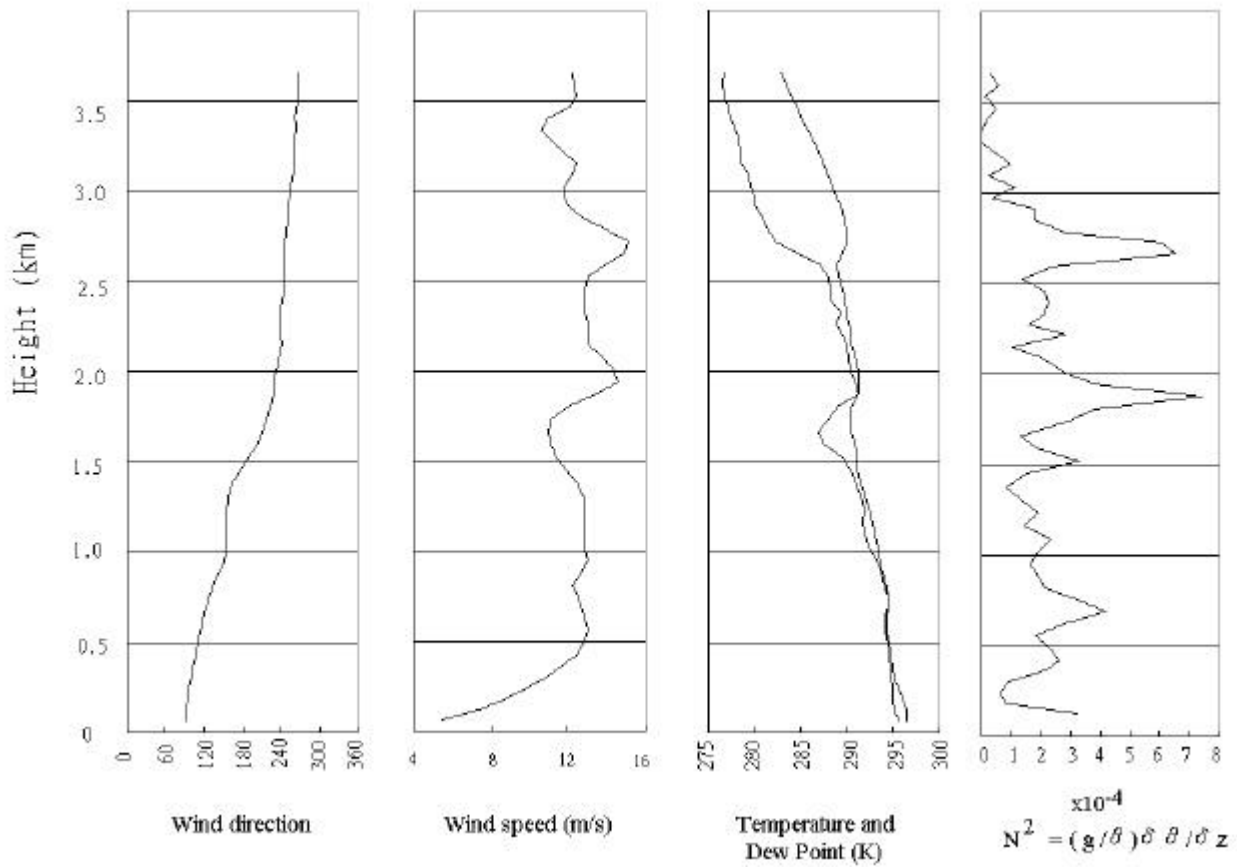
Figure 11 Variation of wind direction, speed, temperature, dew point and N^2 based on the King' s Park radiosonde ascent valid at 12Z 8 March 1999

5.3 The surface easterlies gradually veered with height to become southeasterlies at 925 hPa and southwesterlies at 850 hPa. The 12Z (20H local time) radiosonde ascent on 8 March 1999 at King' s Park revealed shallow low-level inversions at around 750 m (0.2°C) and 1,940 m (1.0°C) (Figure 11) which corresponded to the respective local maxima of N^2 , N being the Brunt-Väisälä frequency.

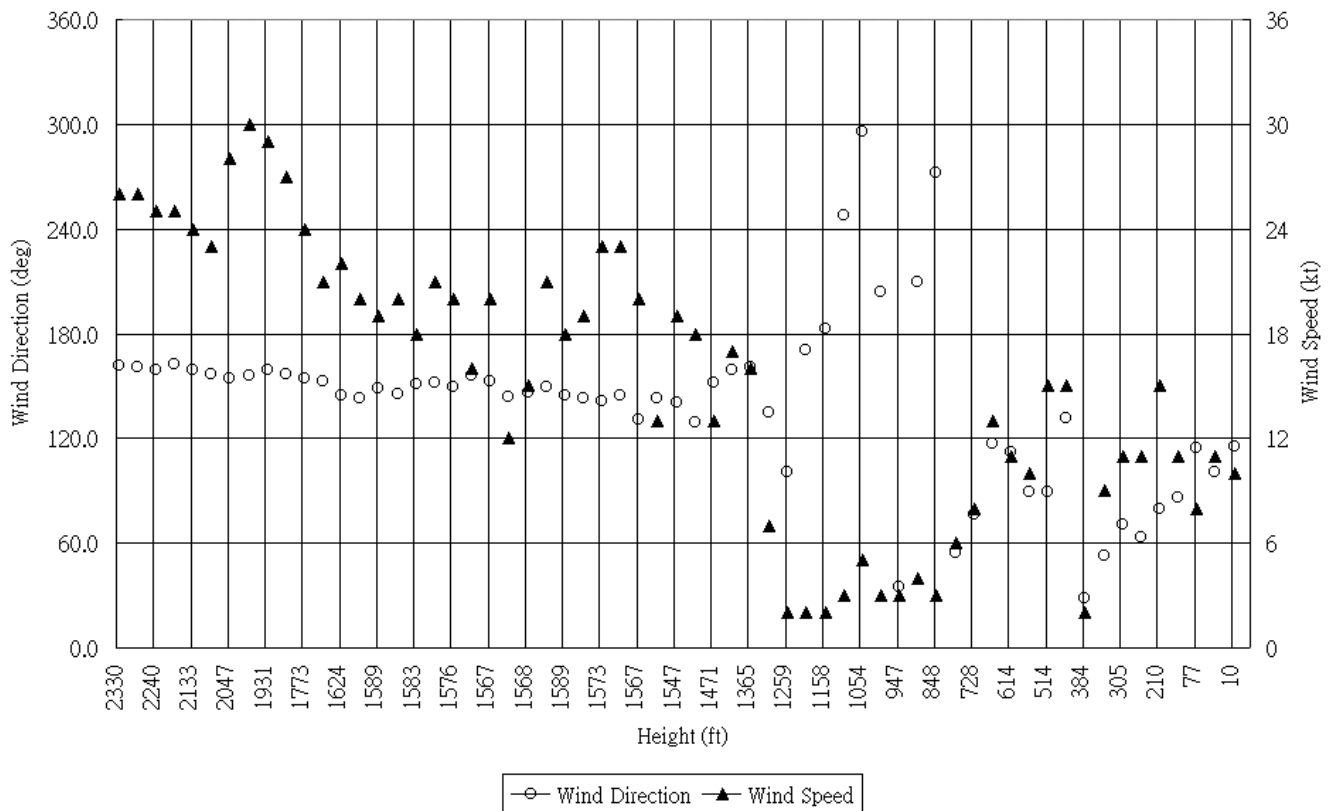
Figure 14 On-board aircraft observed wind direction and speed against the radio height. Data were available every 4 seconds.

5.8 On-board aircraft data from a later flight arriving at 1252Z shows that the aircraft observed winds were basically southeasterlies as the flight descended from 2,300 ft to 1,350 ft amsl (7 to 4 nm from touchdown) (Figure 14). The wind direction then varied significantly, veering to southwest and then northwest as the wind speed dropped markedly to below 5 kt (3 m/s). As the plane continued its descent, the wind direction again changed significantly to northeast at about 800 ft amsl (2.5 nm from touchdown) before veering to southeast as the wind speed increased to 10 to 15 kt (5-8 m/s). The aircraft data thus confirmed the existence of mountain wake with reverse flow (albeit weak) downwind of the northeast- southwest oriented ridge southwest of NLS.
