HONG KONG OBSERVATORY

Technical Note No. 102

WINDSHEAR AND TURBULENCE ALERTING SERVICE AT THE HONG KONG INTERNATIONAL AIRPORT – A REVIEW

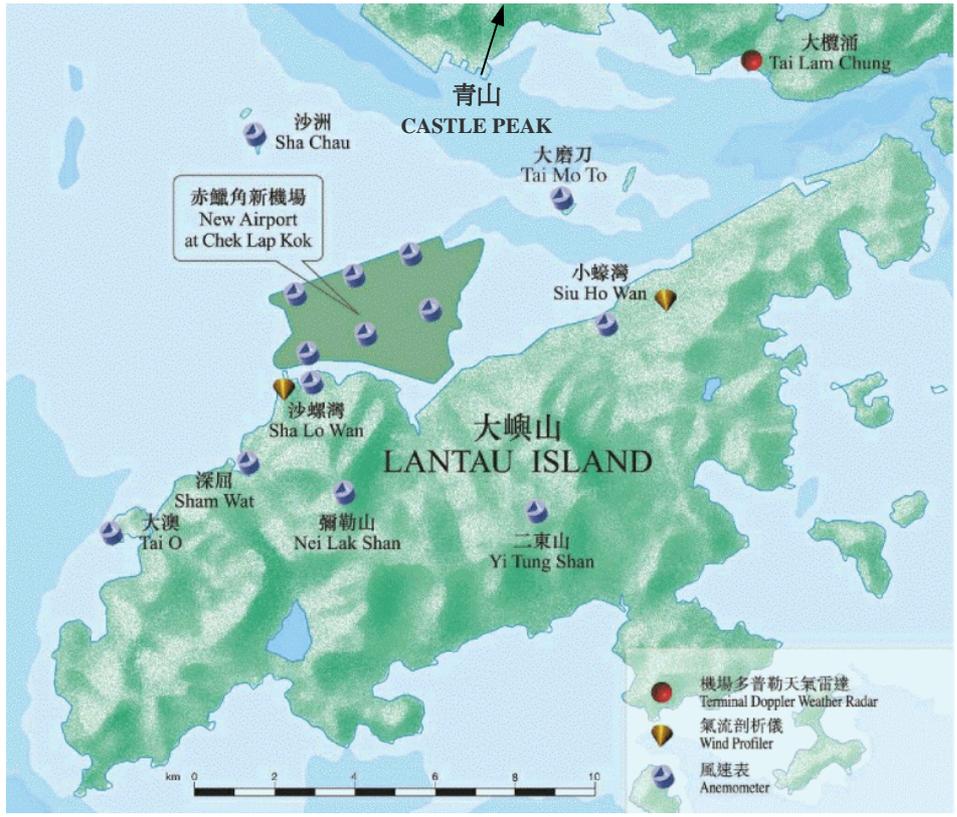
Figure 1 Location of weather sensors in support of the windshear and turbulence alerting service.

- (a) Data from various weather equipment operated by the HKO were studied. These include:
 - (i) wind observations from the TDWR;
 - (ii) vertical wind profiles from wind profilers (vertically-pointing Doppler radars) at Sha Lo Wan and Siu Ho Wan (see Figure 1 for their locations);

- (iii) wind and temperature profiles from the upper-air sounding system at King's Park, some 25 km east of HKIA; and
 - (iv) wind information from a network of anemometers over and around HKIA (see Figure 1 for their locations);
