HONG KONG OBSERVATORY

Technical Note No. 101

**CASE STUDY OF A WINDSHEAR
CAUSED BY LOW-LEVEL JET
14 DECEMBER 1998**

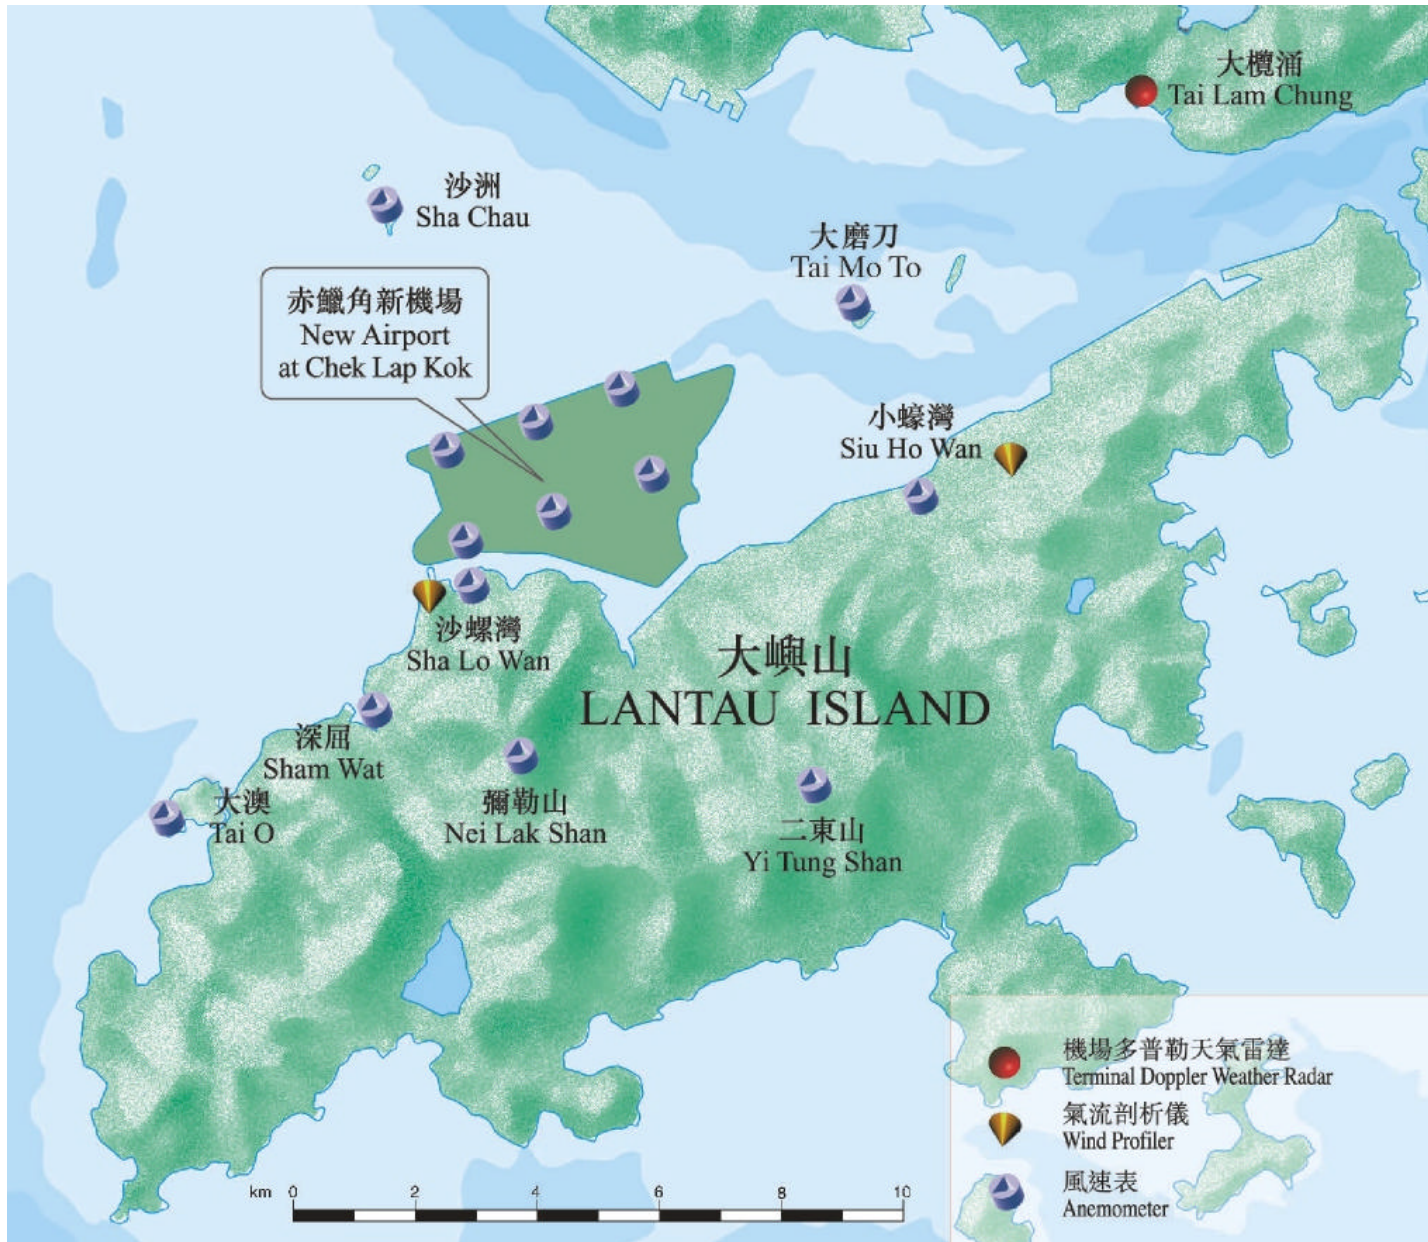
Figure 1. Meteorological Equipment for windshear and turbulence detection at and around Chek Lap Kok

The TDWR is strategically located at Tai Lam Chung, about 12 kilometers northeast of CLK to give it a clear view of the runways, airport approach and departure areas (Fig. 1). It was purposely built to serve the terminal area of the airport and detects microburst and windshear associated with convective storms. Similar TDWRs have been widely deployed for operational use in major U.S. airports.

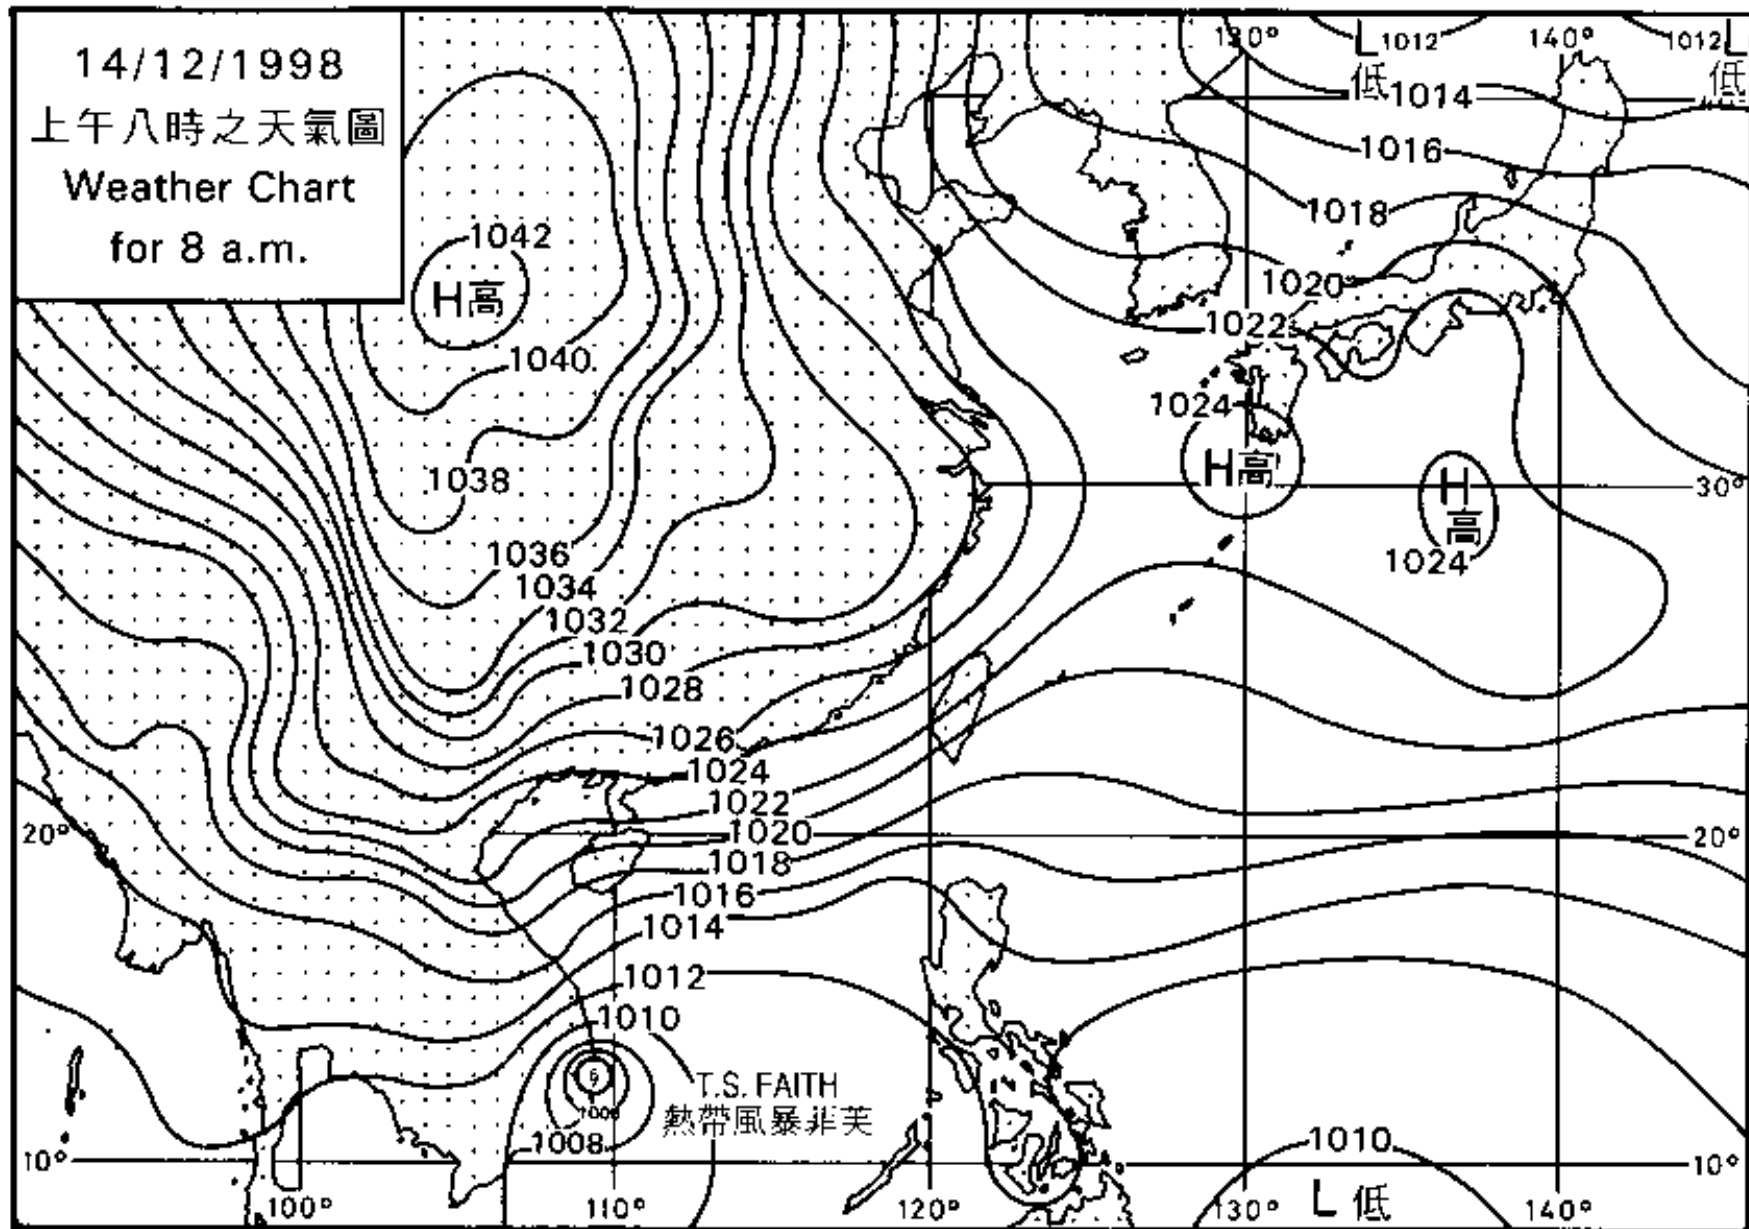
Figure 2. Surface Weather Chart as at 00Z 14 December 1998

A northerly surge reached Hong Kong on 11 December 1998. The northerlies moderated on 12 and 13 December but strengthened again on 14 December. The surface weather chart is given in Fig. 2. The Strong Monsoon Signal was hoisted at noon and remained in force throughout the day. Fig. 3(a) to (c) show the 850 hPa (around 5,000 ft), 700 hPa (around 10,000 ft) and 500 hPa (around 19,000 ft) upper-air analysis valid at 00Z on 14 December 1998. At 850 hPa, the northerly airstream and the moist southeasterly airstream converged over the South China coastal waters. A 500 hPa westerly trough was approaching Hong Kong with strong south to southwesterly winds over the southern China. There were also strong south to southwesterly winds over southern China at 700 hPa.

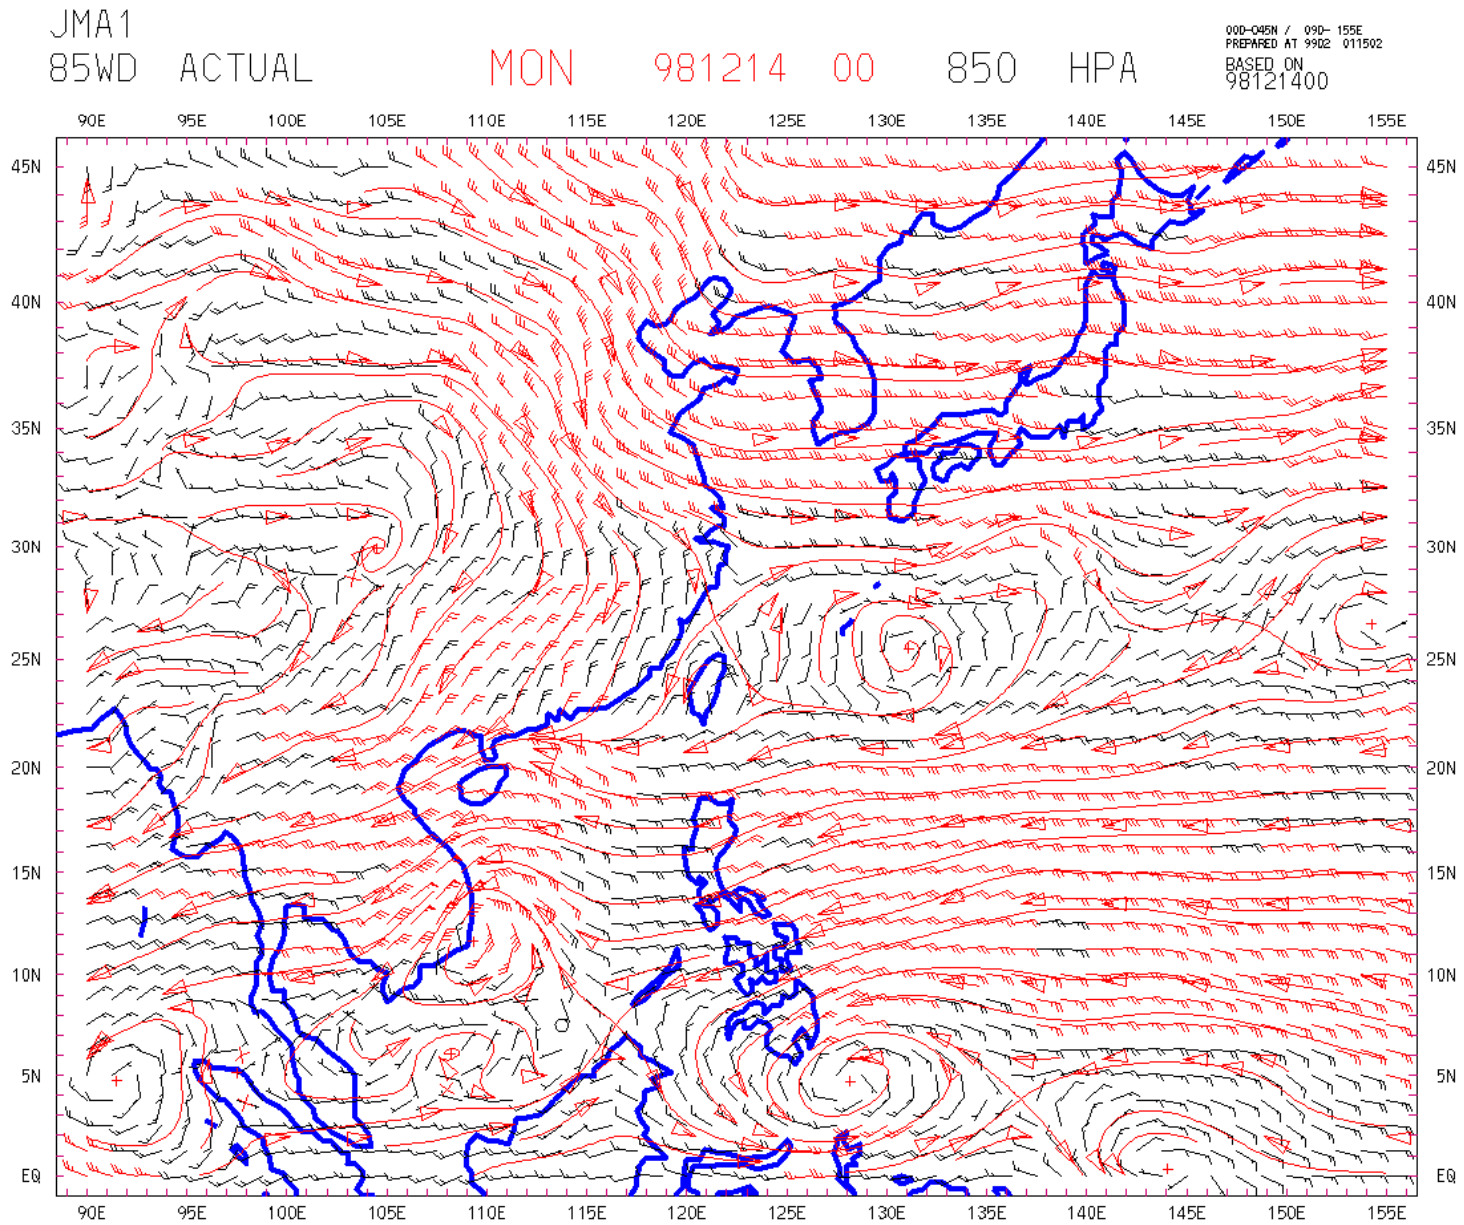
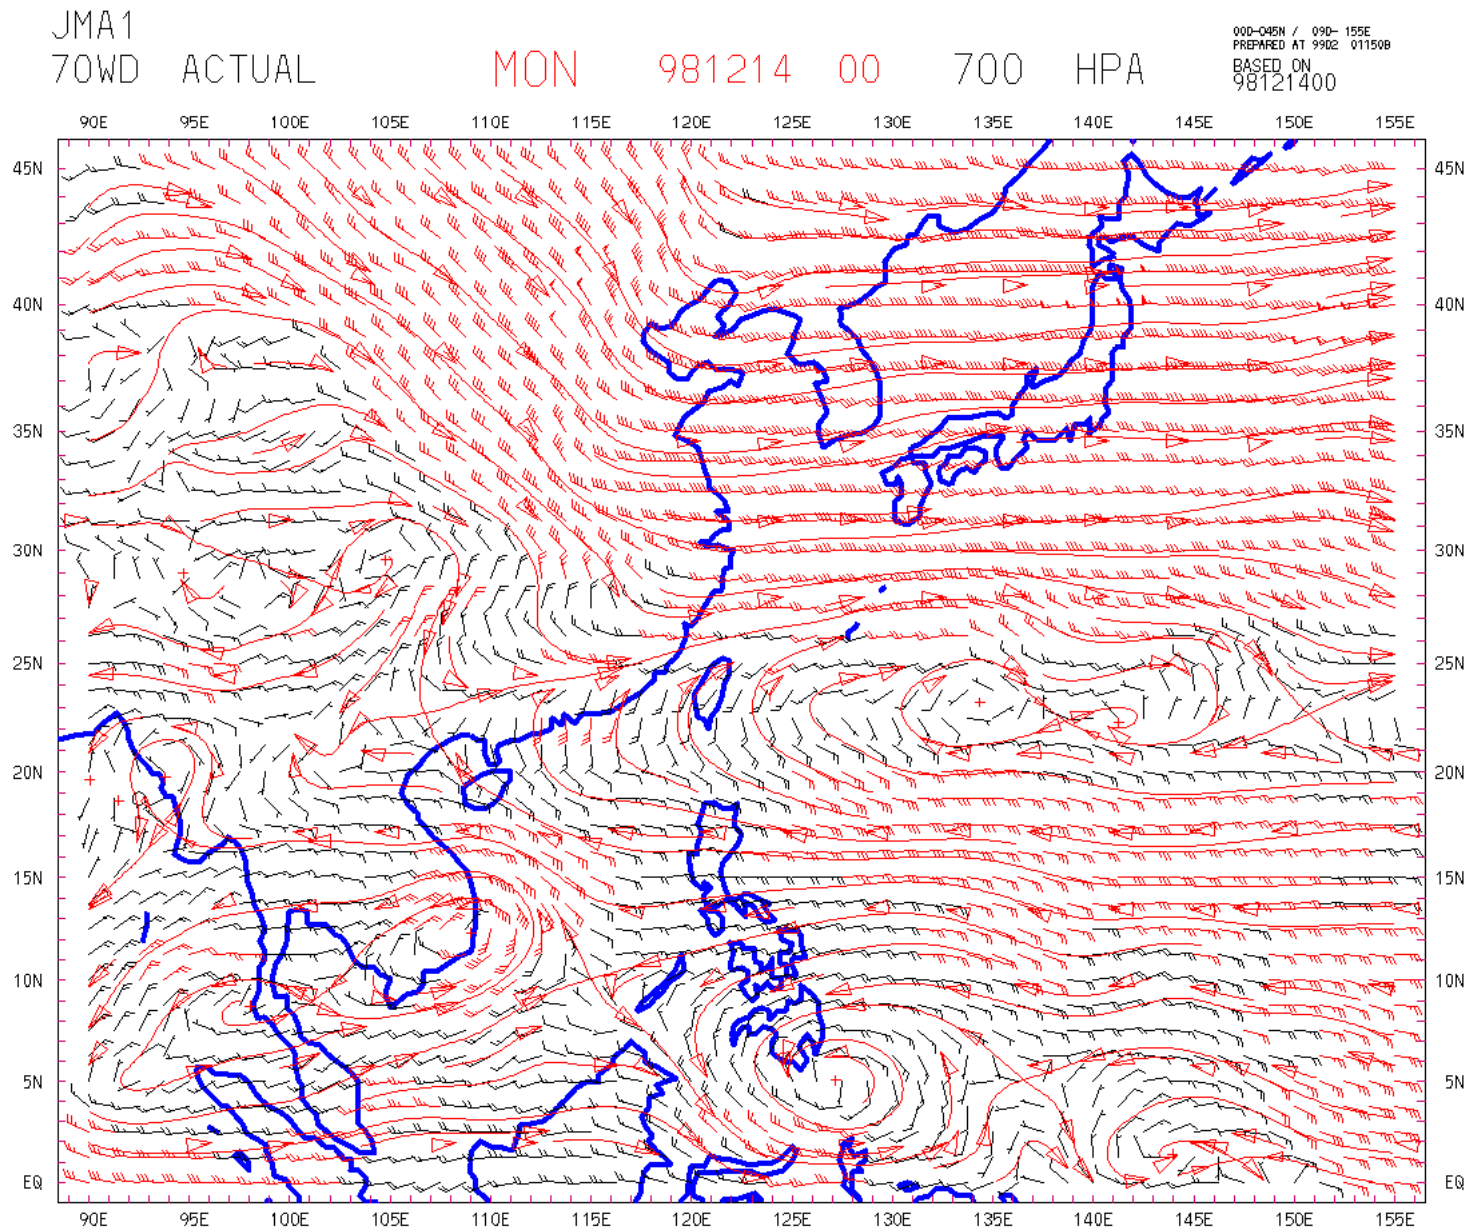
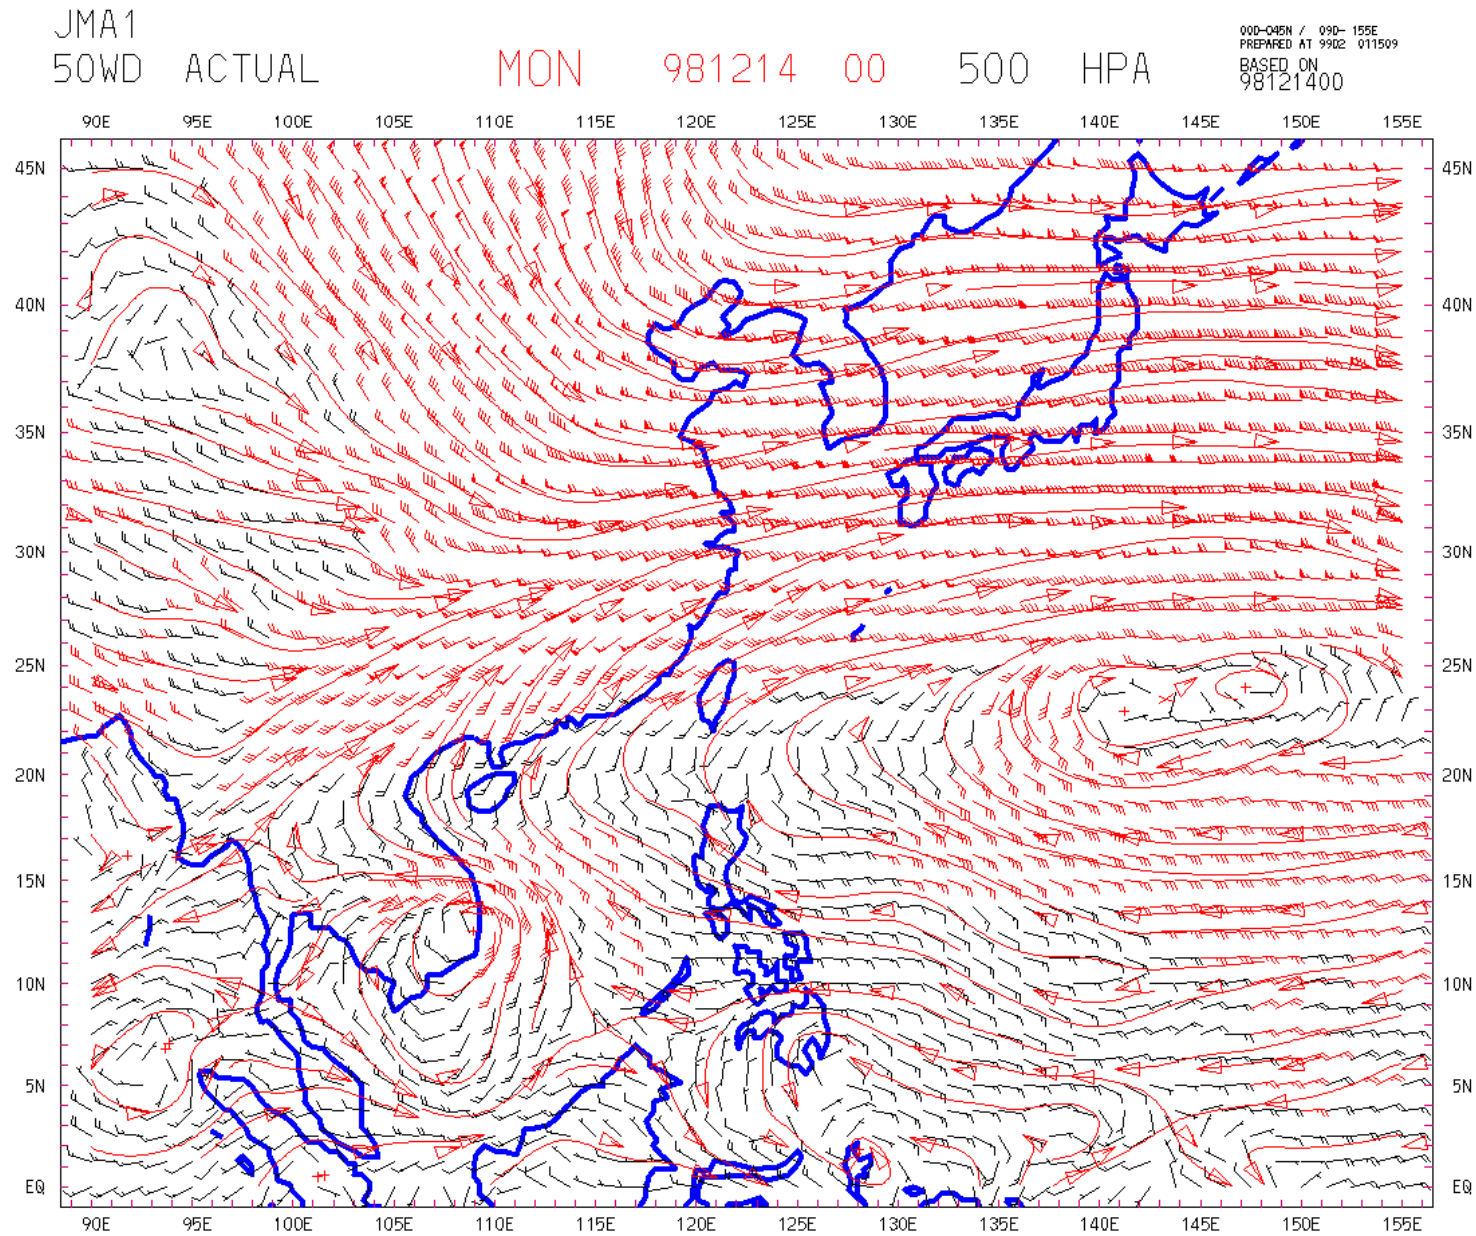
Figure 3(a). 850 hPa winds valid at 00Z on 14 December 1998 (based on JMA analysis)

Figure 3(b). 700 hPa winds valid at 00Z on 14 December 1998 (based on JMA analysis)

Figure 3(c). 500 hPa winds valid at 00Z on 14 December 1998 (based on JMA analysis)

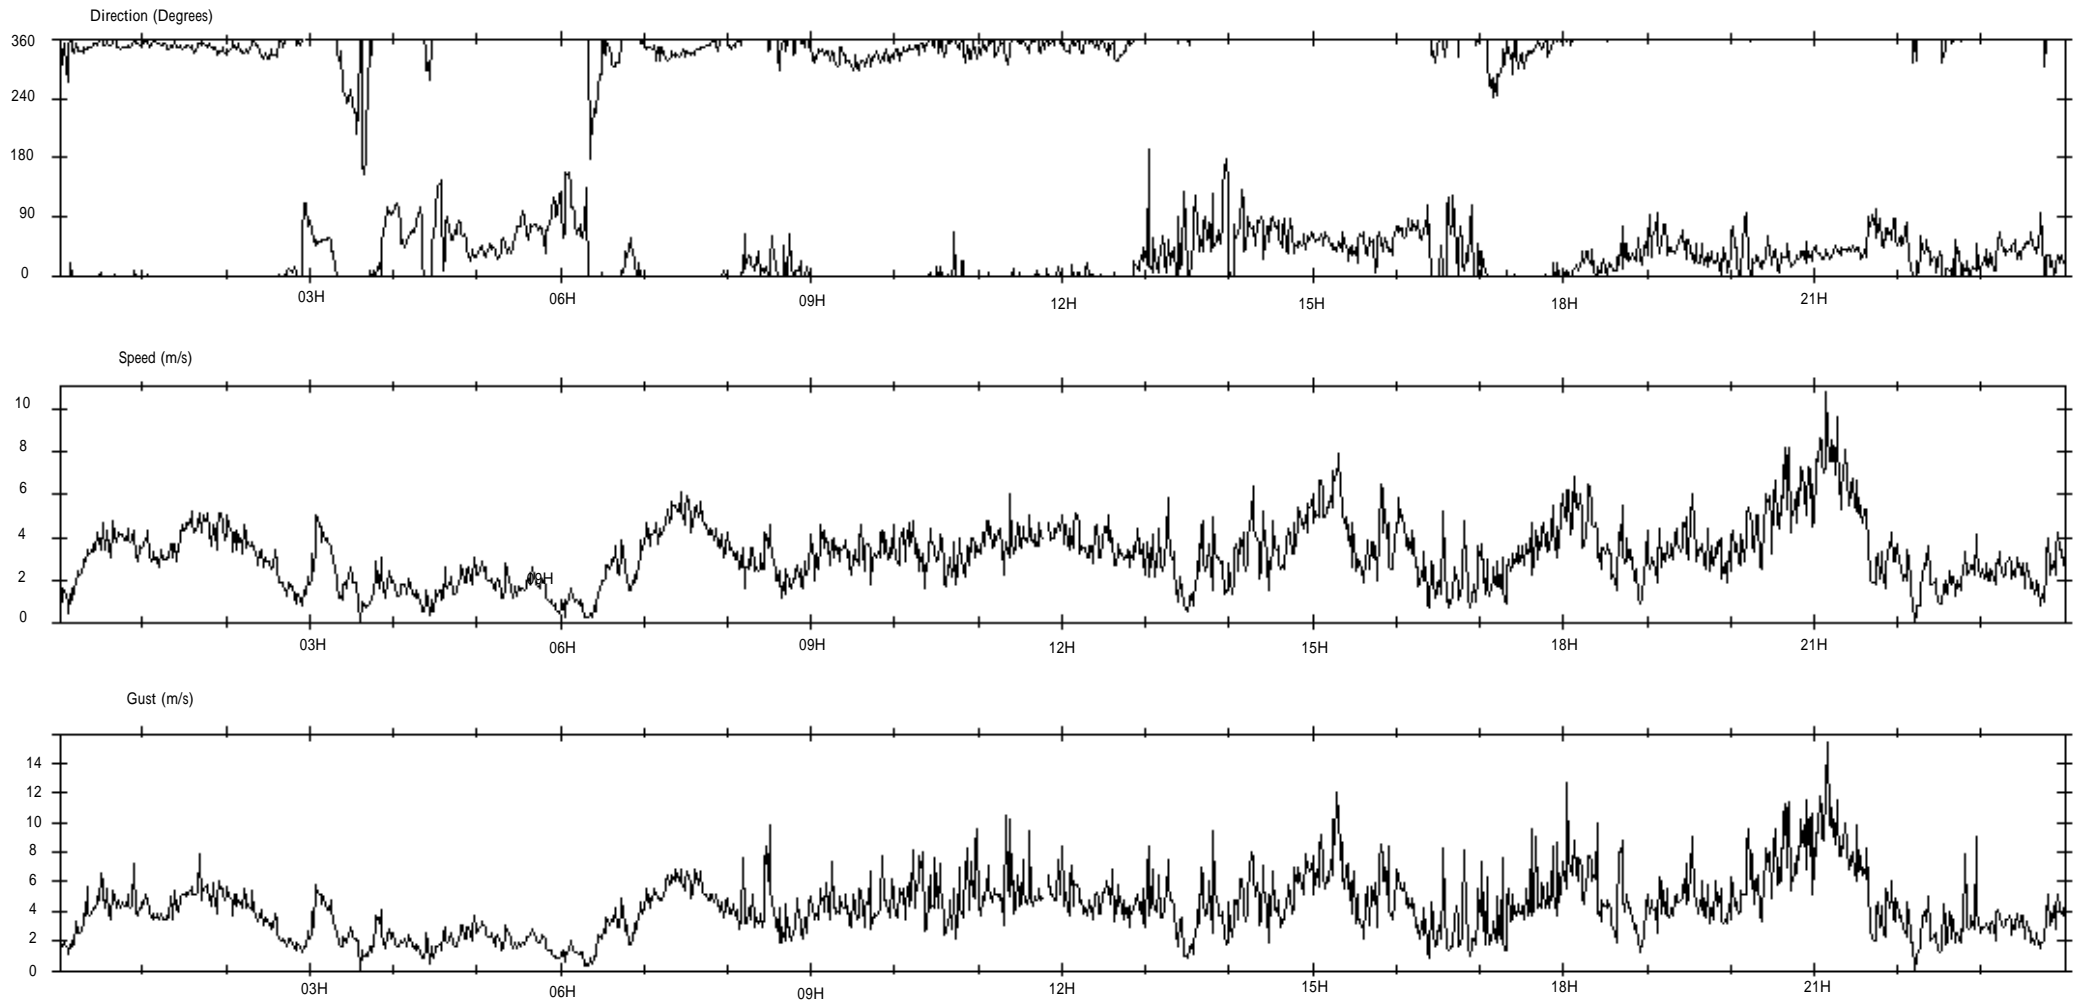
Figure 4. Surface Winds at Chek Lap Kok on 14 December 1998

Surface winds at CLK were northerlies around 10 kt throughout the morning and afternoon (Fig. 4). However, winds on mountain tops on Lantau, namely Nei Lak Shan and Yi Tung Shan were generally gale force (40-50 kt) in the afternoon (Fig. 5). The Sha Lo Wan profiler captured a low-level jet at around 2,000 ft (Fig. 6). The low-level jet is even more prominent at Shamshuipo (Fig. 7). The presence of the low-level jet was also well captured by the Terminal Doppler Weather Radar (TDWR) 6° scan. At 0741Z the core of the low-level jet was observed to have a radial speed of 40 kt or above (coloured in pink to red in Fig. 8) extended from around 800 m to 1,200 m, in fairly good agreement with the Sha Lo Wan profiler data. Above 1,200 m, the radial speed dropped gradually again in good agreement with the Sha Lo Wan profiler data.

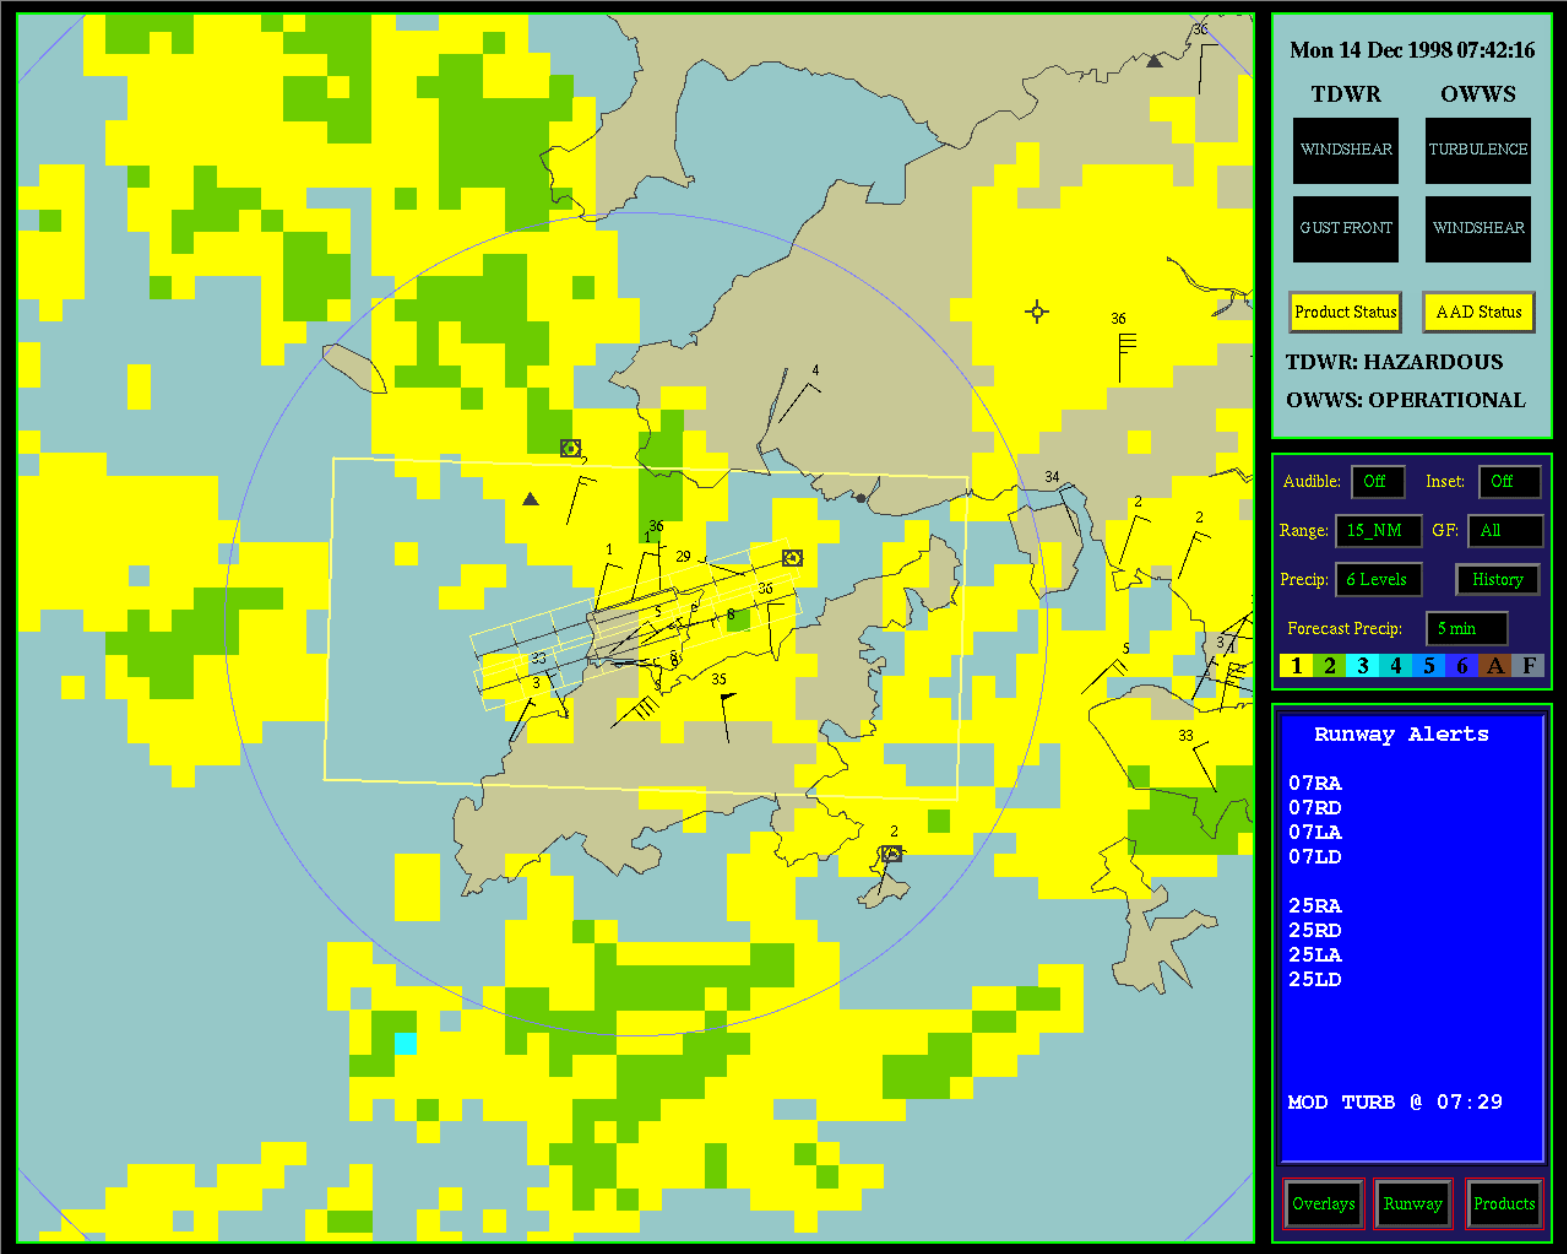
Figure 5. Geographical Situation Display as at 0742Z on 14 December 1998

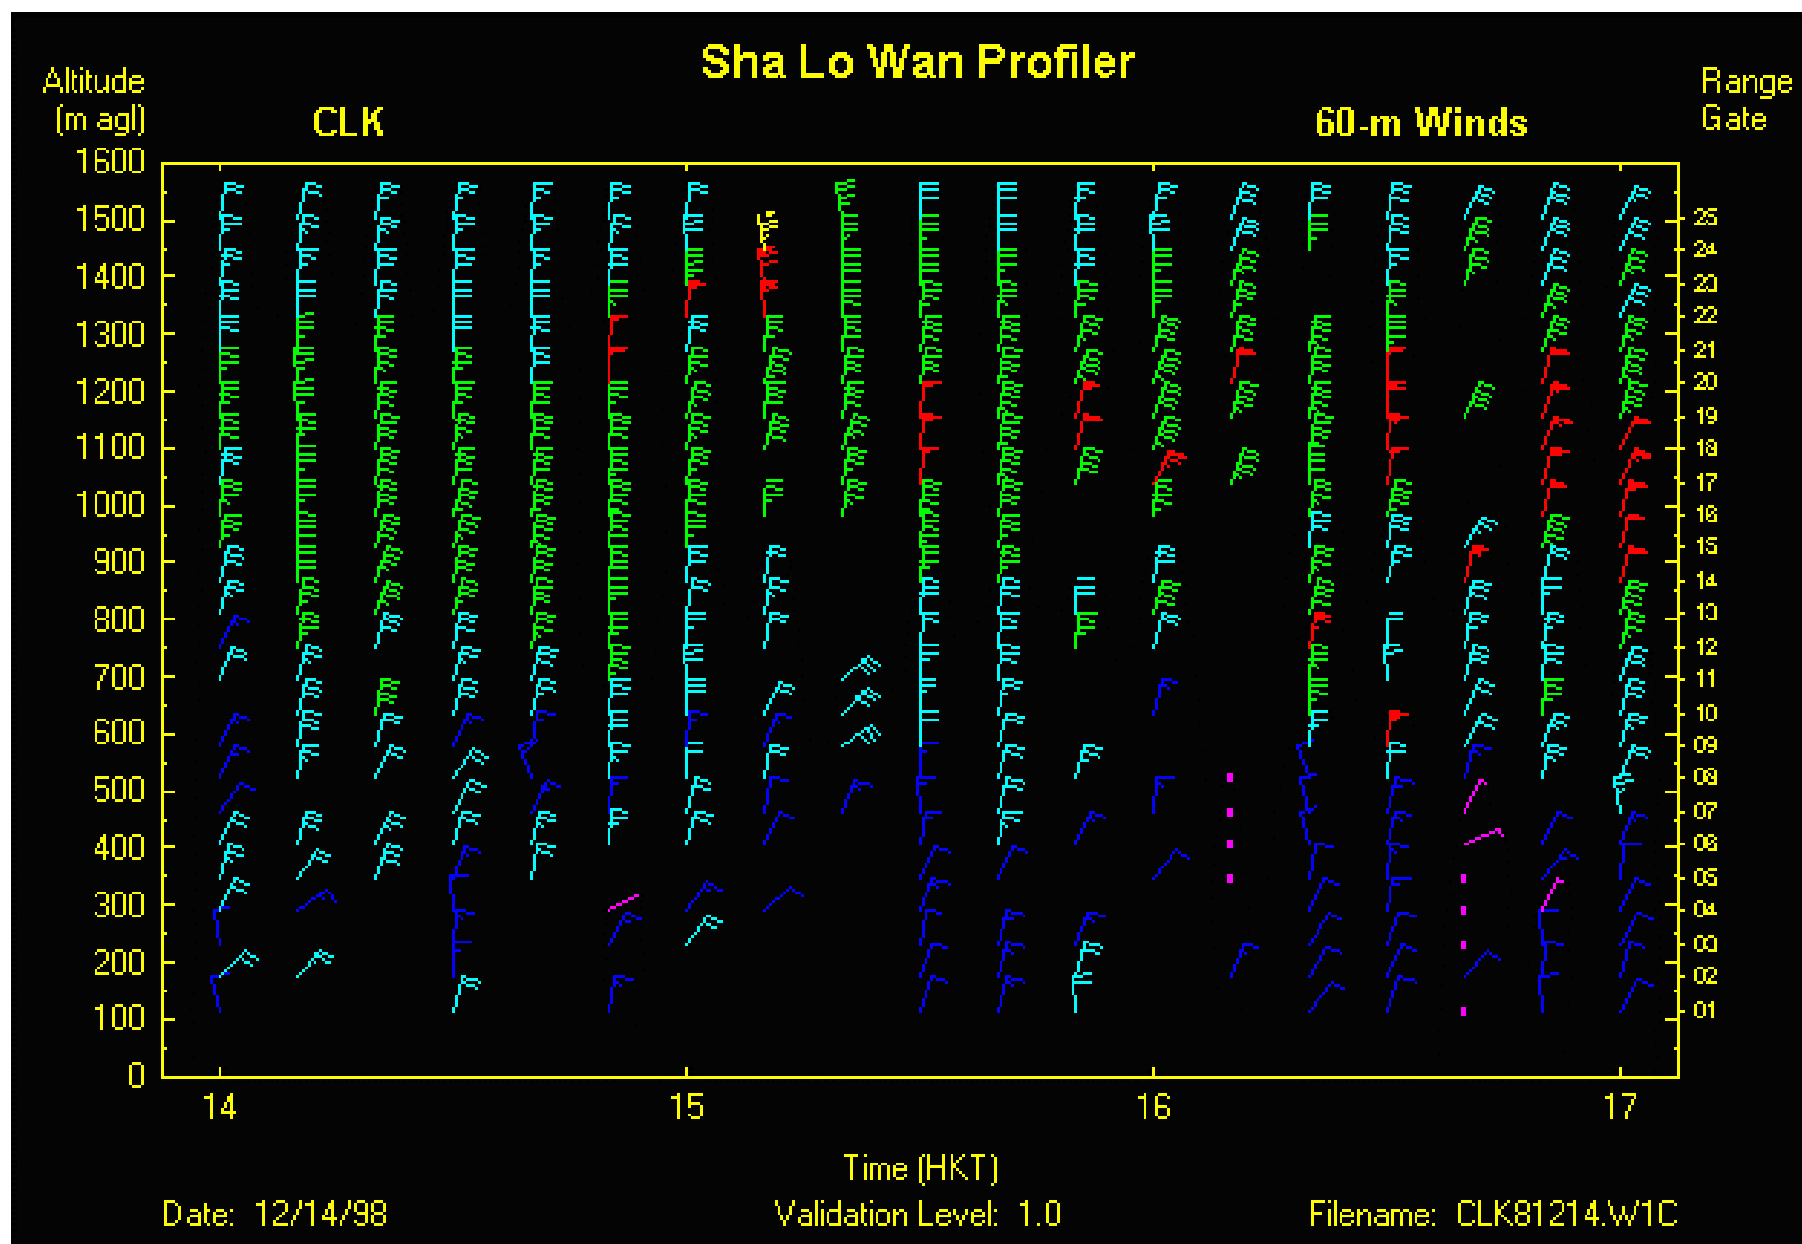
Figure 6. Winds measured by Sha Lo Wan Wind Profiler on the afternoon of 14 December 1998

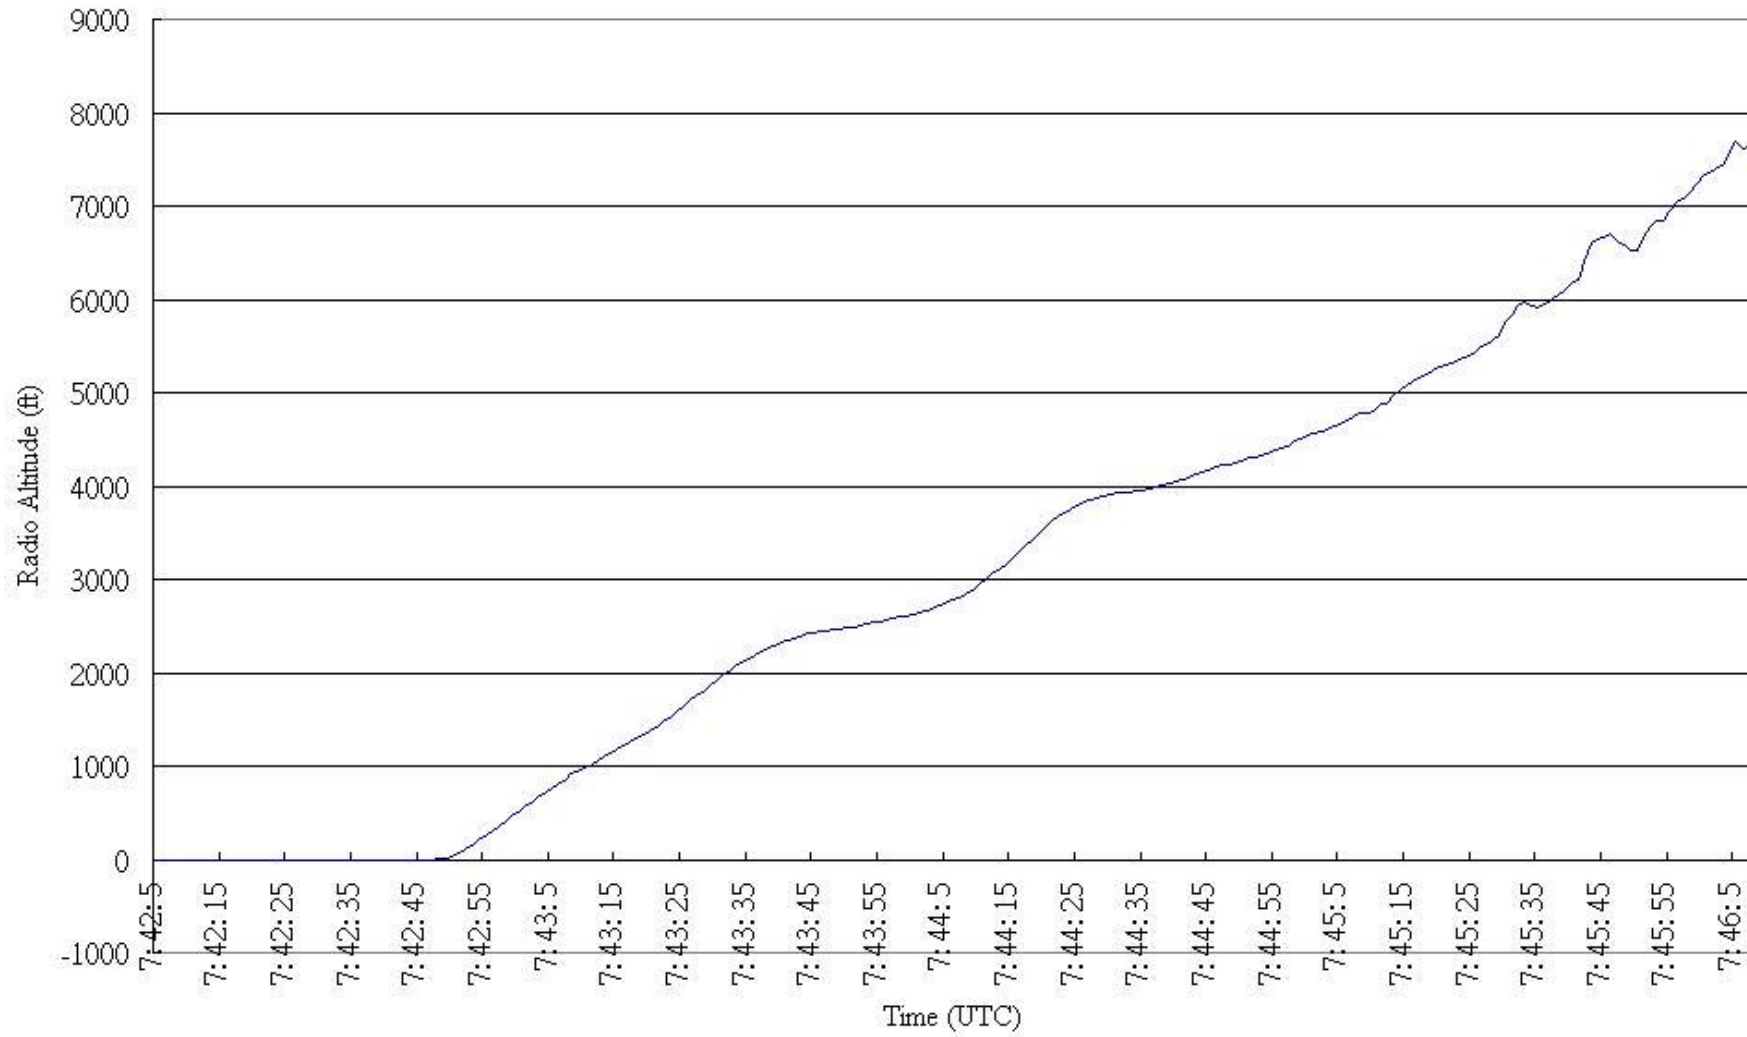
Figure 9. Variation of Altitude with Time

The flight took off at 07:42:48 Z (Fig. 9). Based on the radio altitude, this flight climbed at around 9.6° , slightly steeper than the 7° climb of the flight at 0751Z.

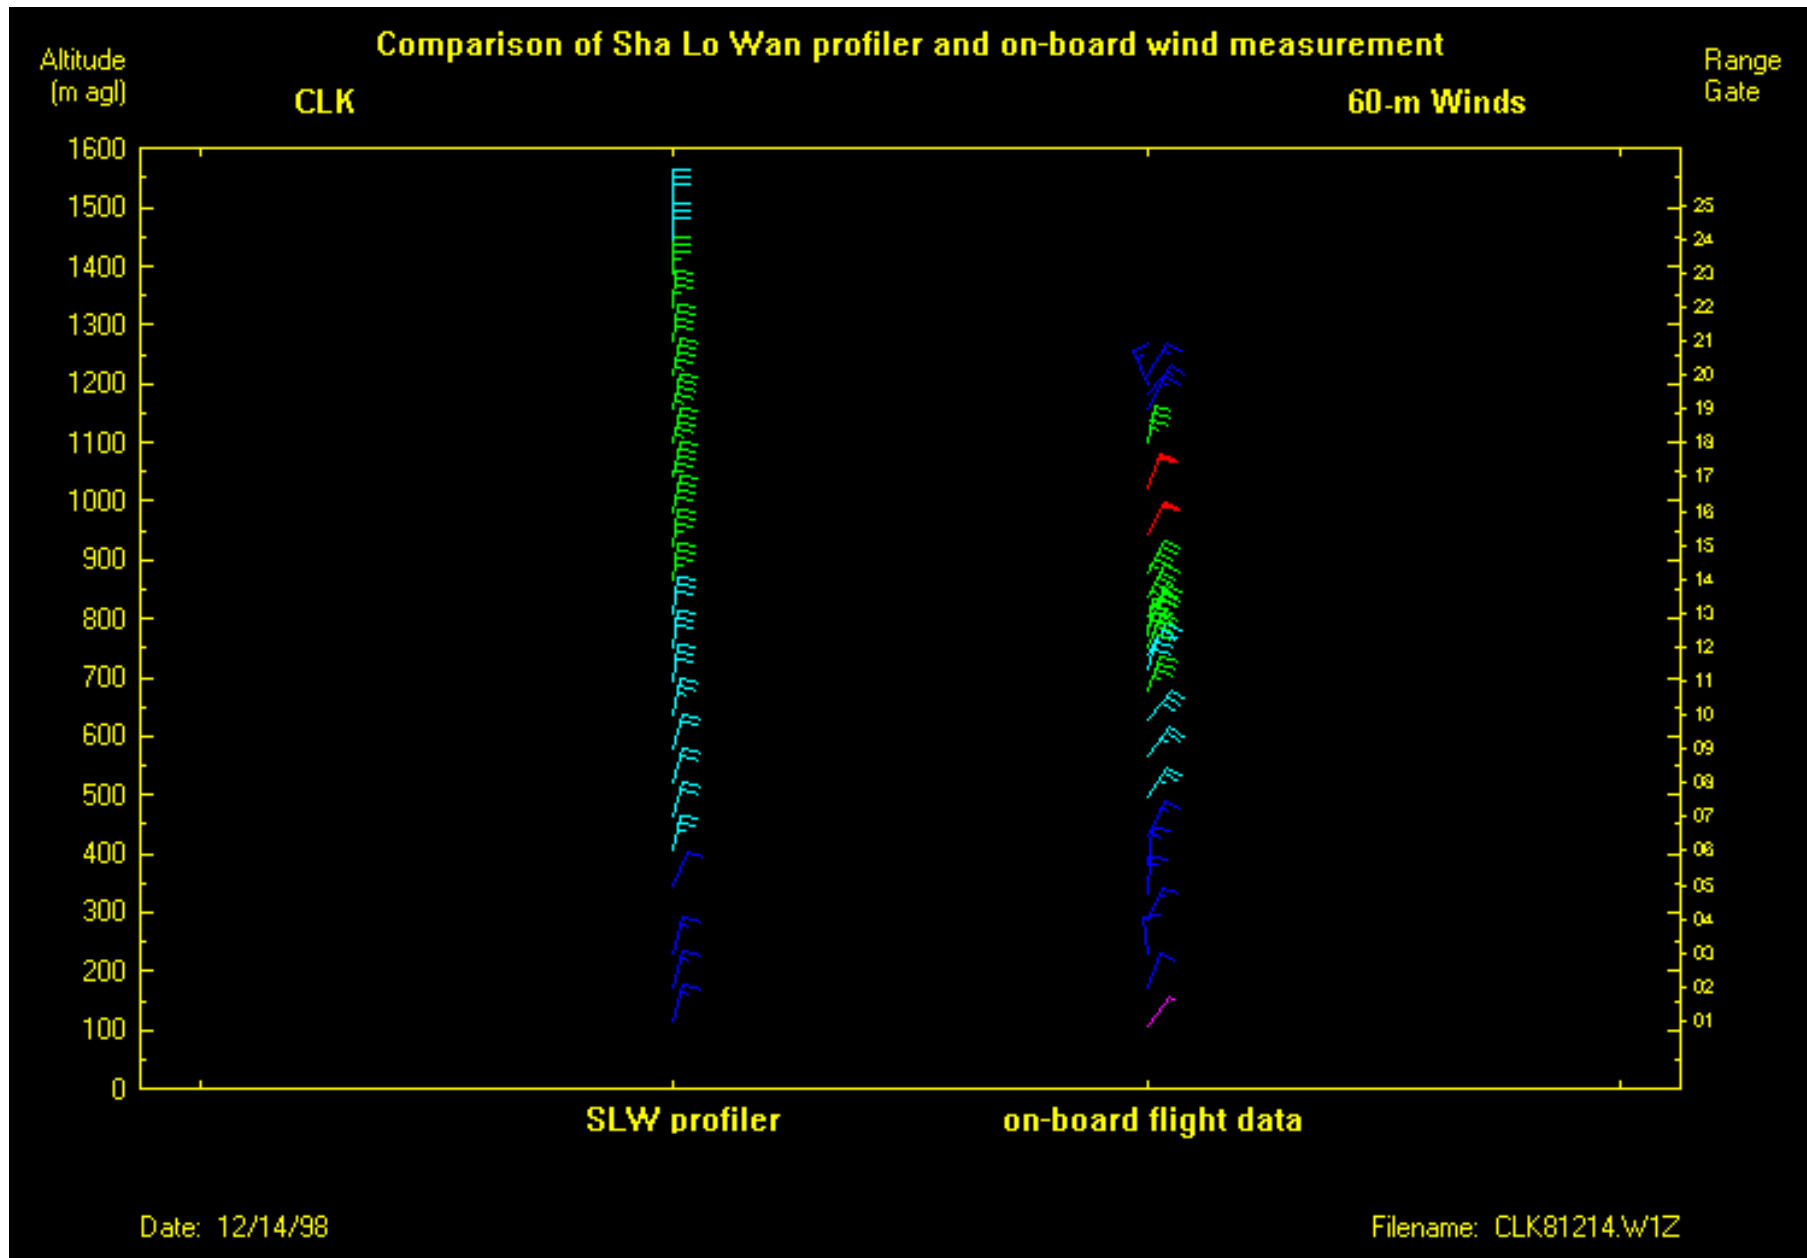
Figure 10. Comparison of Winds Measured On-board with those from Sha Lo Wan Profiler

It is noted that the winds measured on-board had a greater easterly component than those from the Sha Lo Wan profiler (Fig. 10). Based on the wind measured on-board, winds were 10 kt or less from near the surface up to around 800 ft. Winds then increased rapidly and were the strongest at around 3,350 ft, reaching 50 kt. Between 1,600 and 3,350 ft, the winds observed on-board were generally larger than those measured by the Sha Lo Wan profiler. The wind speed recorded by the aircraft then dropped sharply to around 15 kt at 3,800 ft which was much sharper than that detected by the Sha Lo Wan profiler and TDWR. As a result of the sudden drop in wind speed and thus the head wind, the pitch attitude decreased by 6.7° (0.12 rad) in 11 seconds (Fig. 11).

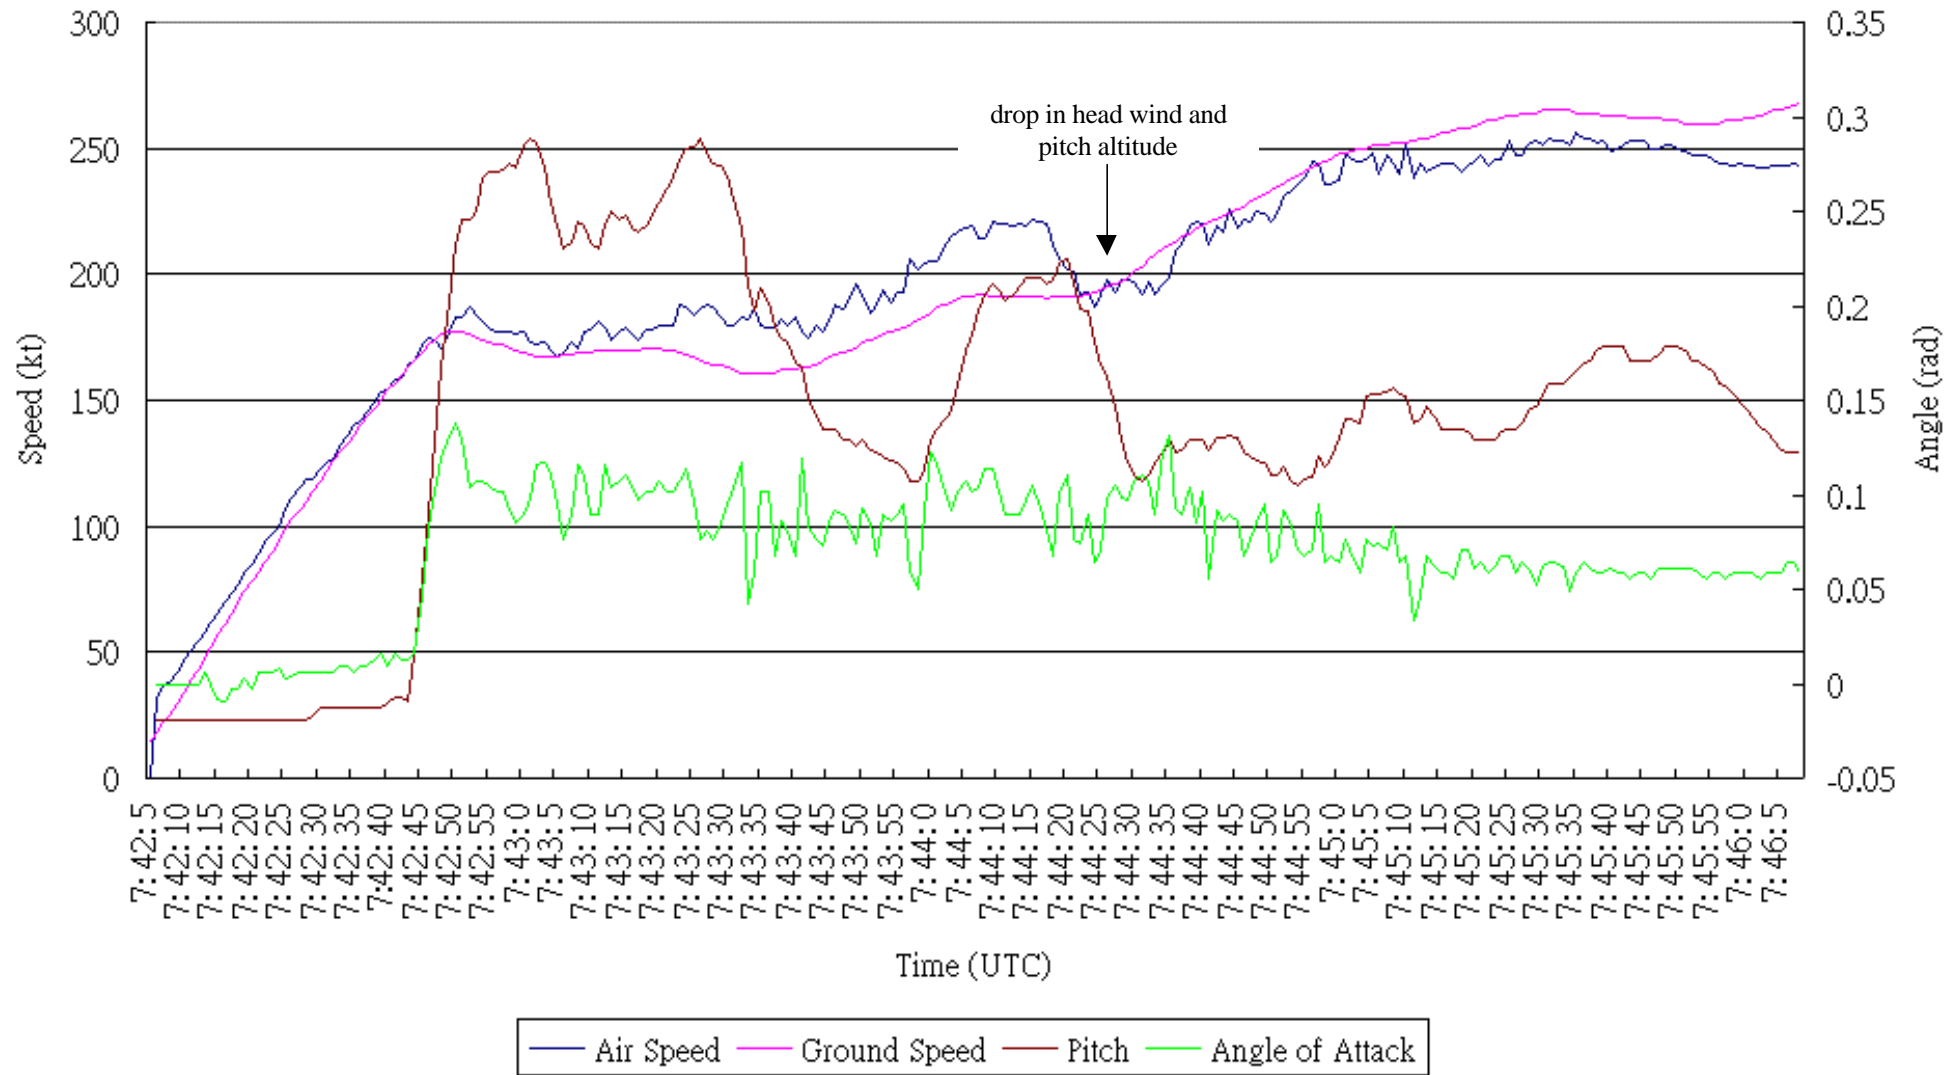
Figure 11. Variation of Air Speed, Ground Speed, Pitch and Angle of Attack with Time
