HONG KONG OBSERVATORY

Technical Note No. 101

**CASE STUDY OF A WINDSHEAR
CAUSED BY LOW-LEVEL JET
14 DECEMBER 1998**

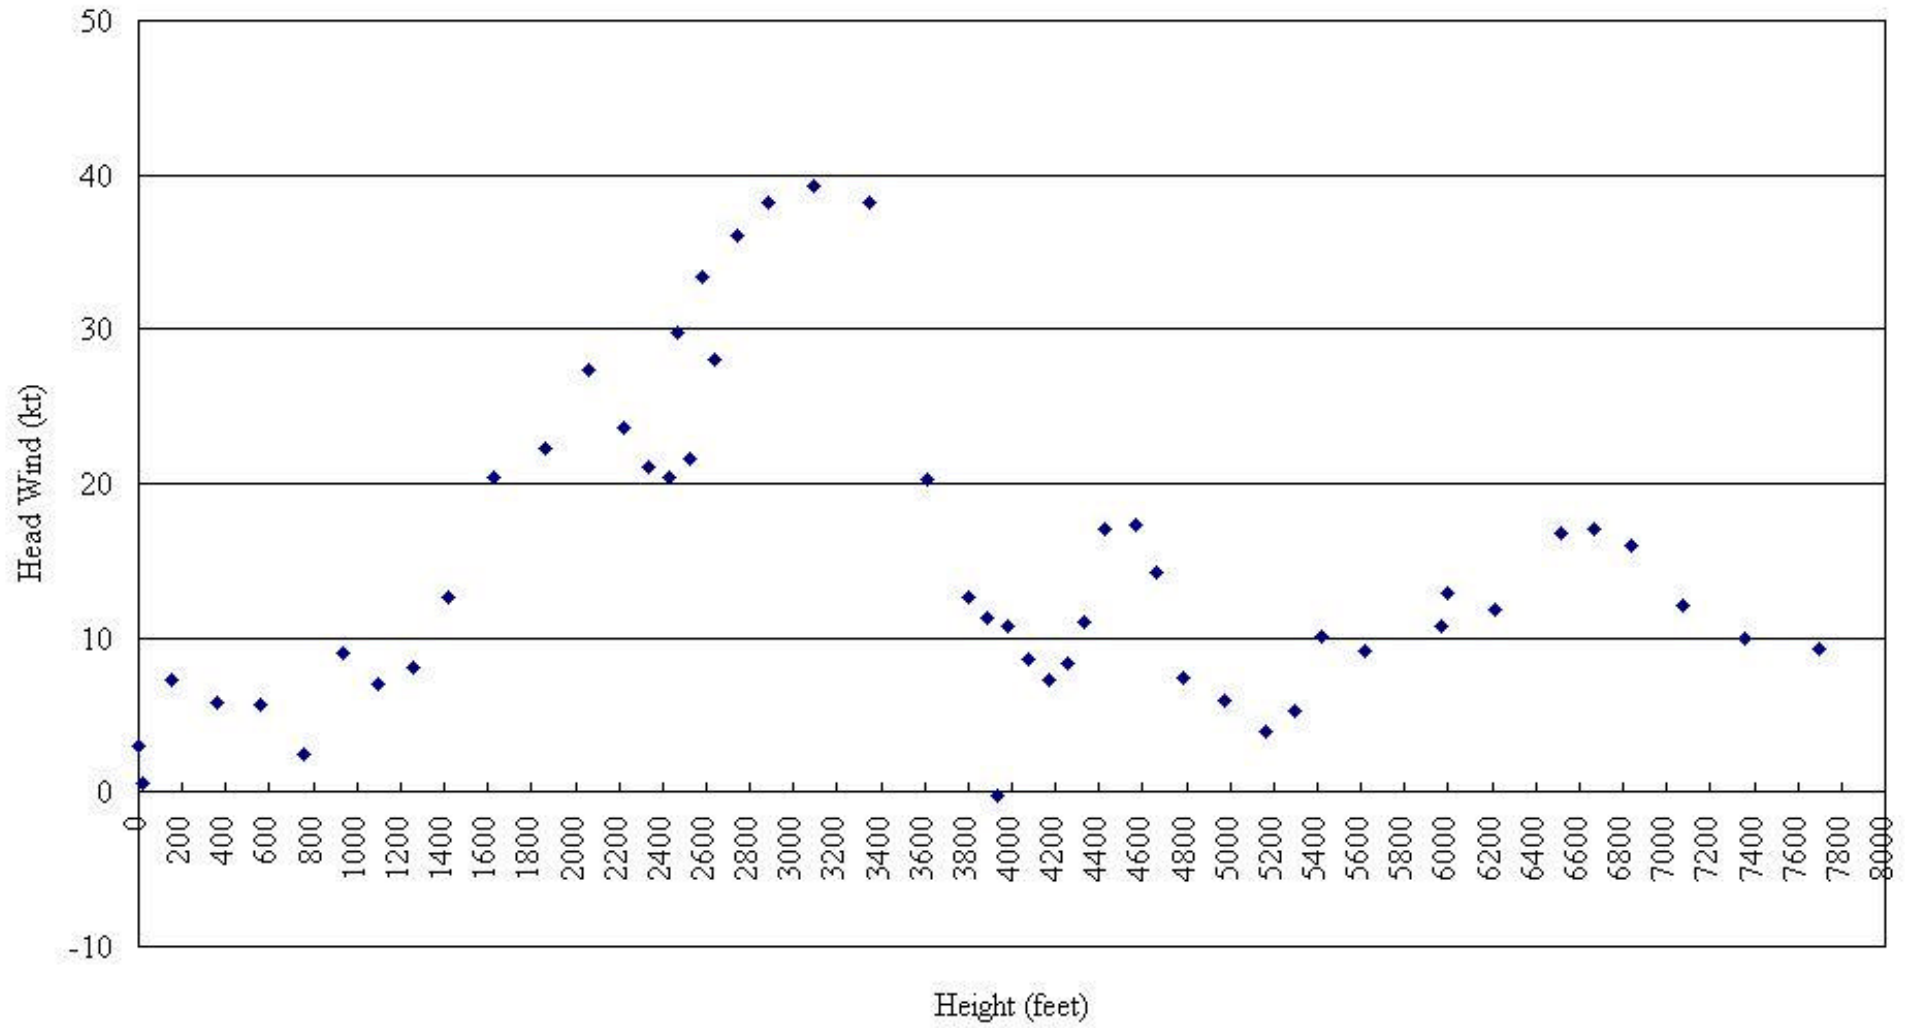
Figure 12. Variation of Head Wind with Height

Due to the rapid increase in the wind speed, there was a rapid increase in head wind component, from 13 kt at 1,420 ft to 39 kt at 3,100 ft (Fig. 12). The average head wind gain over the period was 1.6 kt per 100 ft. Using the on-board flight data and considering only the head wind change component, the F-Factor (head wind change component) was 0.027.

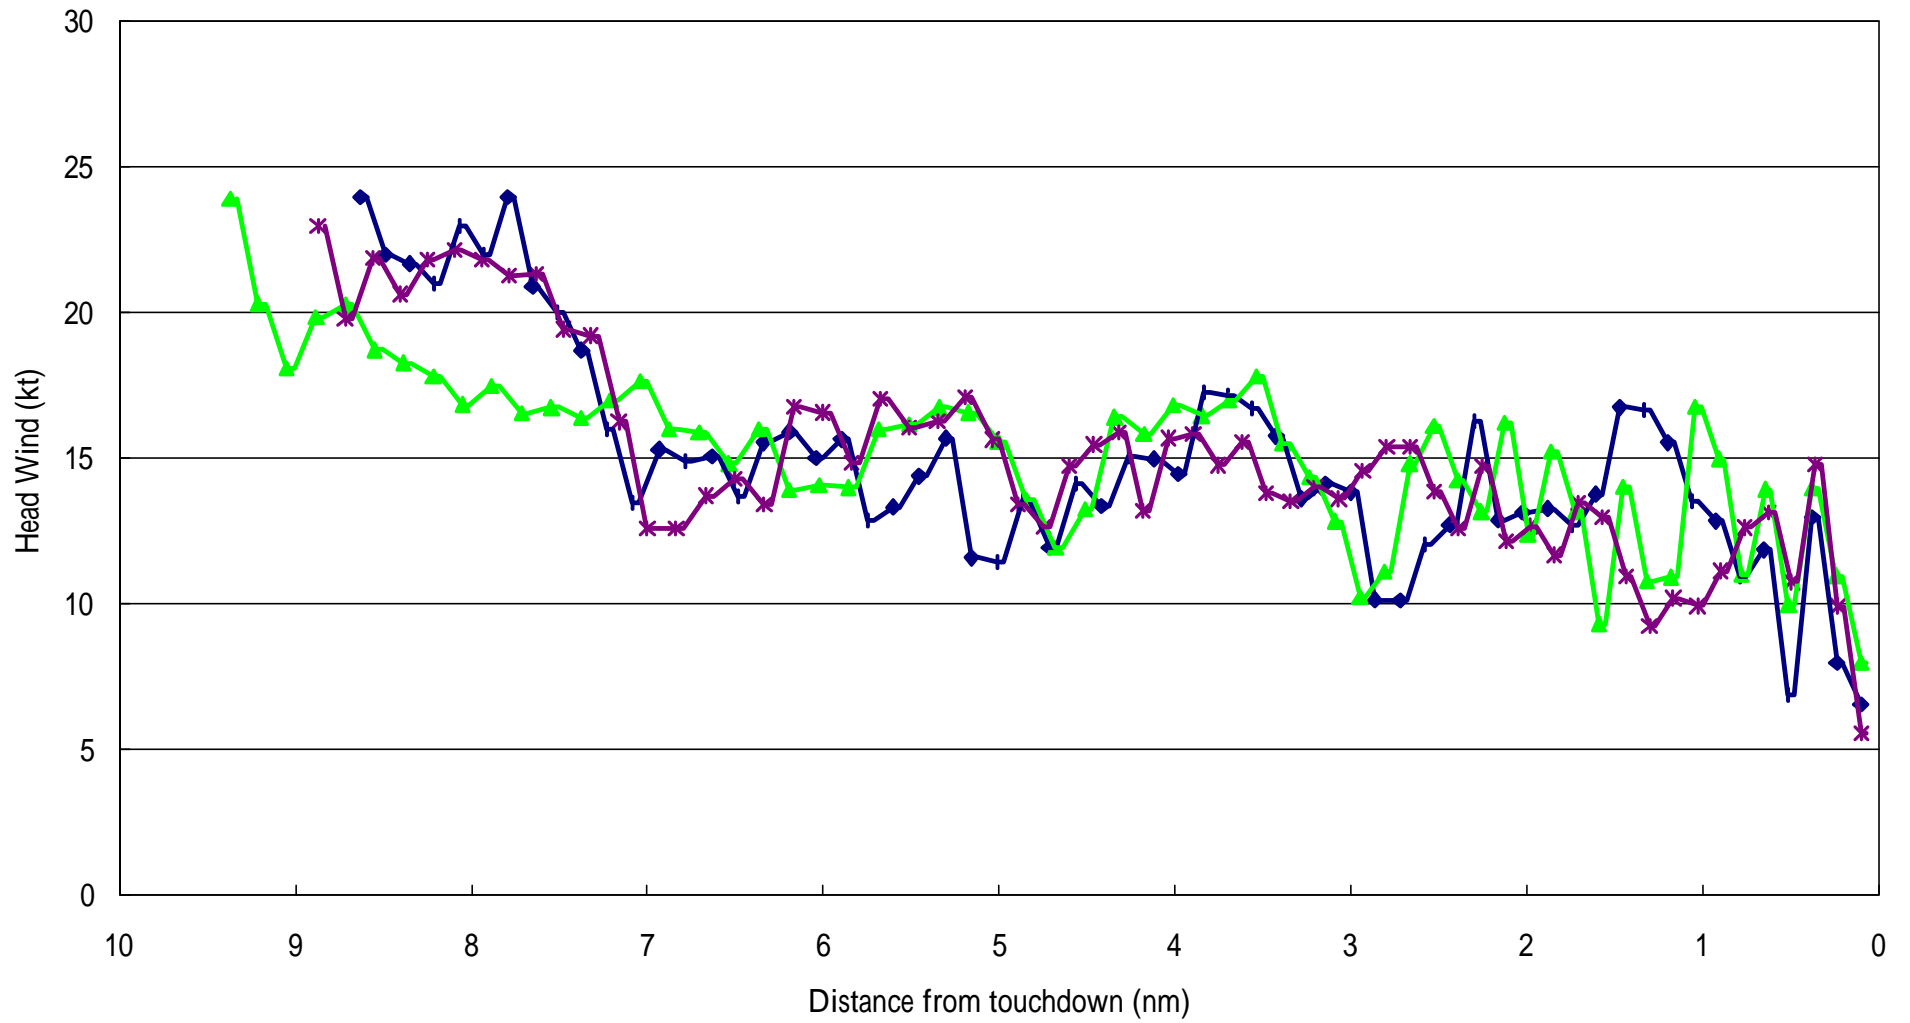
Figure 13. Variation of head wind with distance for 3 flights arriving between 0635 and 0655 UTC 14 December 1998

and that the shear was encountered very close to the end of the runway. Meanwhile for arriving flights, which descended at a lesser angle (3°), no significant shear was experienced within 9 nm from touchdown (Fig. 13).

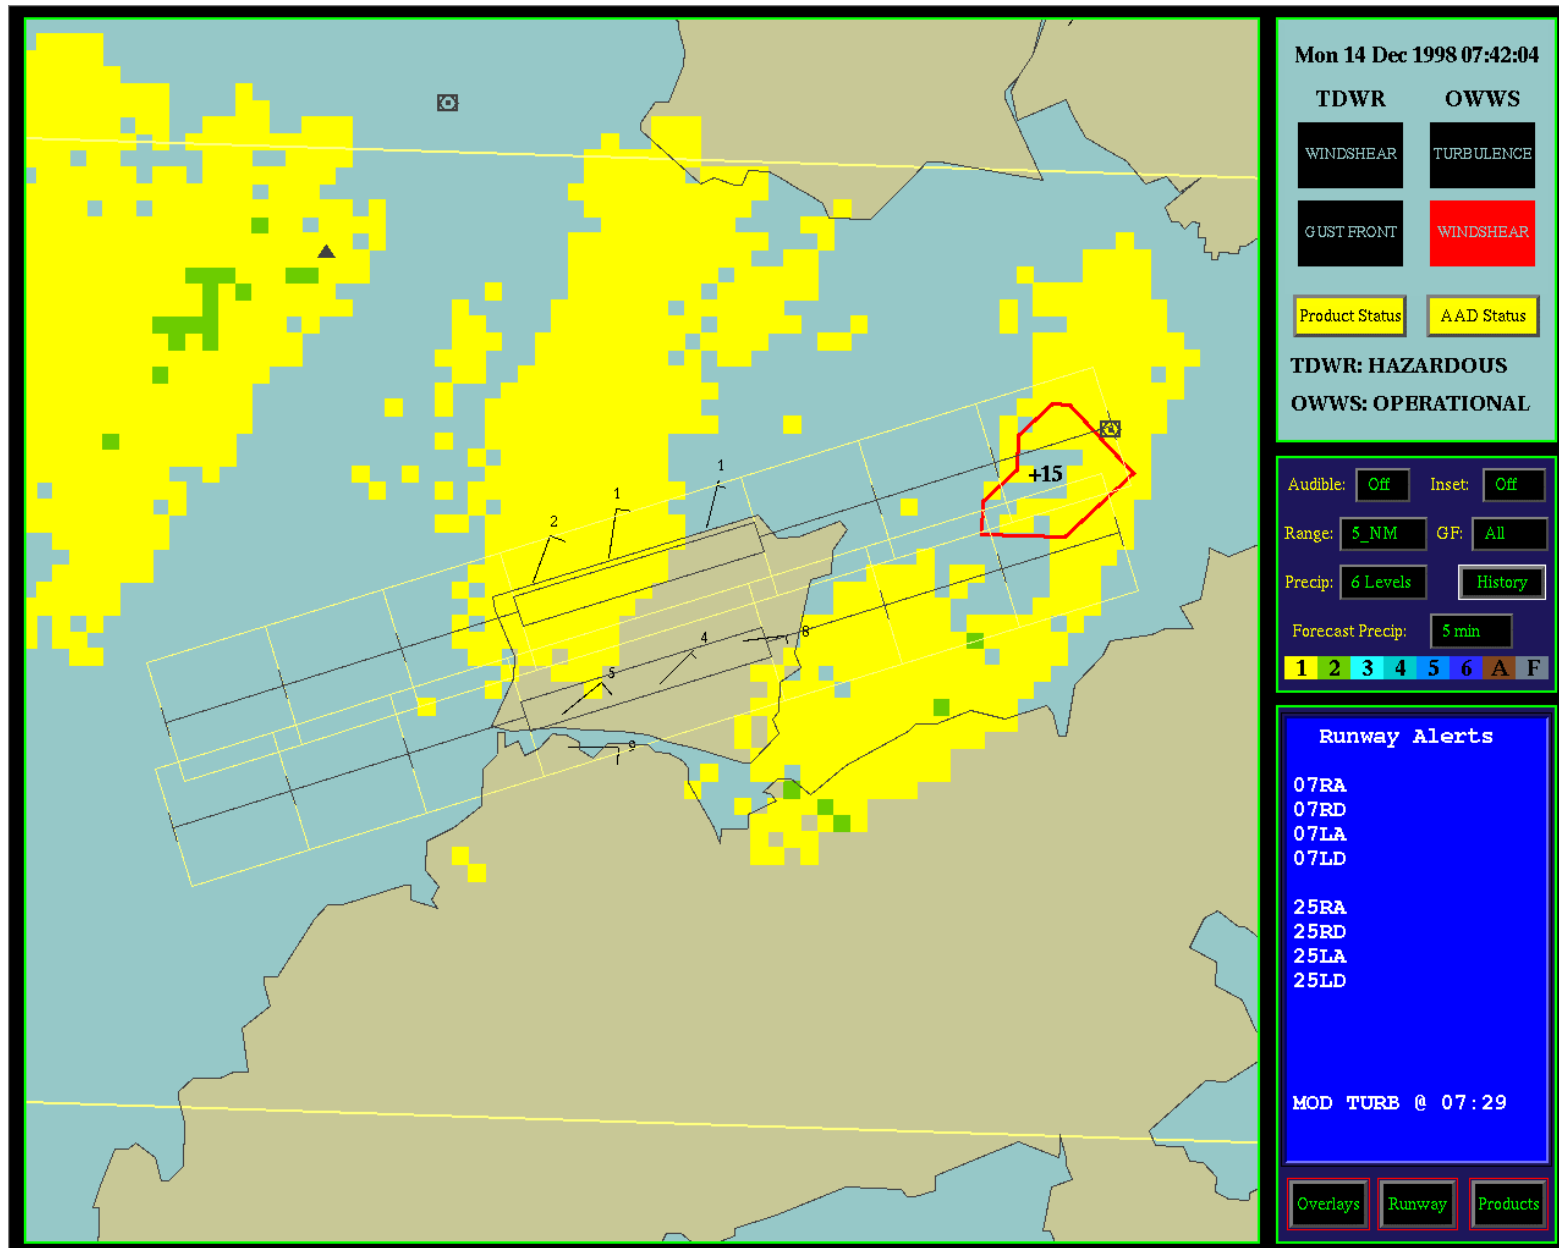
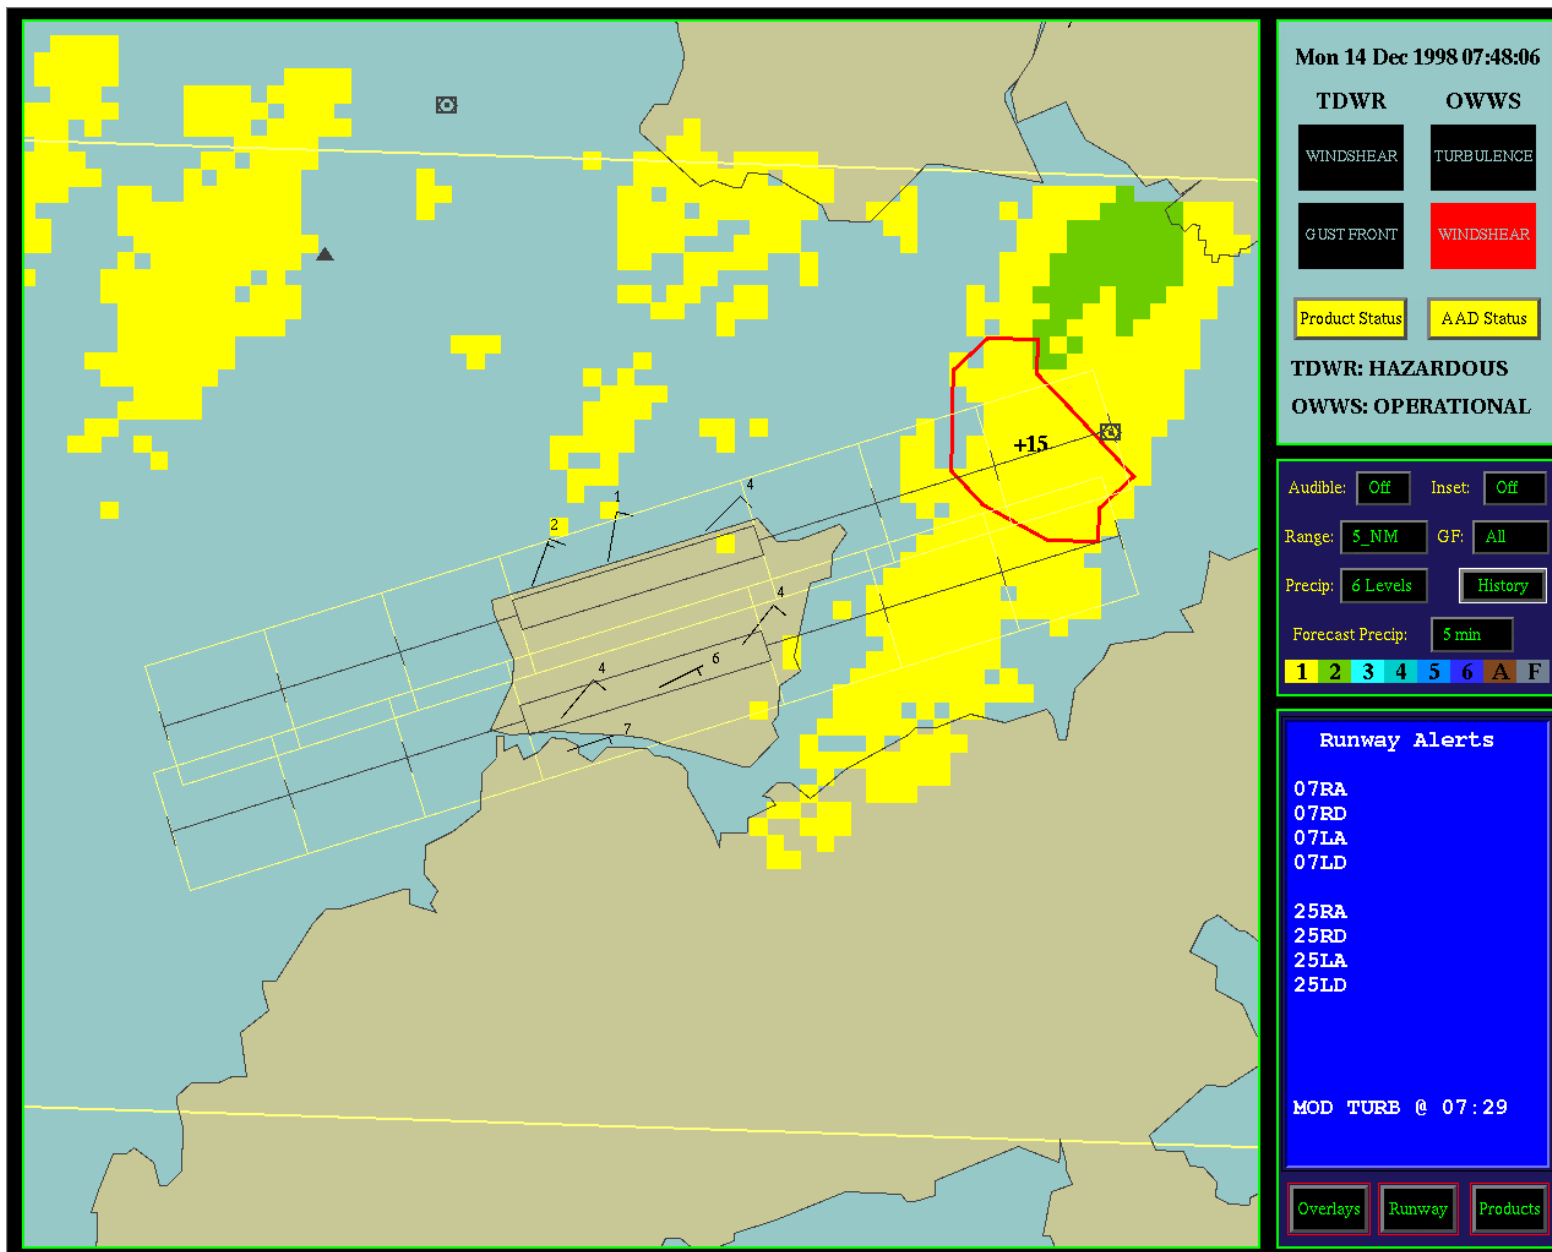
Figure 14. Geographical Situation Display as at 0742Z on 14 December 1998

Figure 15. Geographical Situation Display as at 0748Z 14 December 1998

The WTWS windshear algorithm, which uses the radial winds measured by the TDWR for windshear detection, was operational at the time. No windshear alert was generated by the WTWS for the southern runway. The WTWS did generate moderate turbulence alert temporarily for RWY 07RD at 0730Z. The WTWS also detected lifting windshear over RWY 07D and a windshear shape was generated on the graphical situation display at 0742 and 0748Z close to the time when the aircraft reported windshear (Fig. 14 and 15). However, the shear magnitude was not strong enough and no alert was generated.

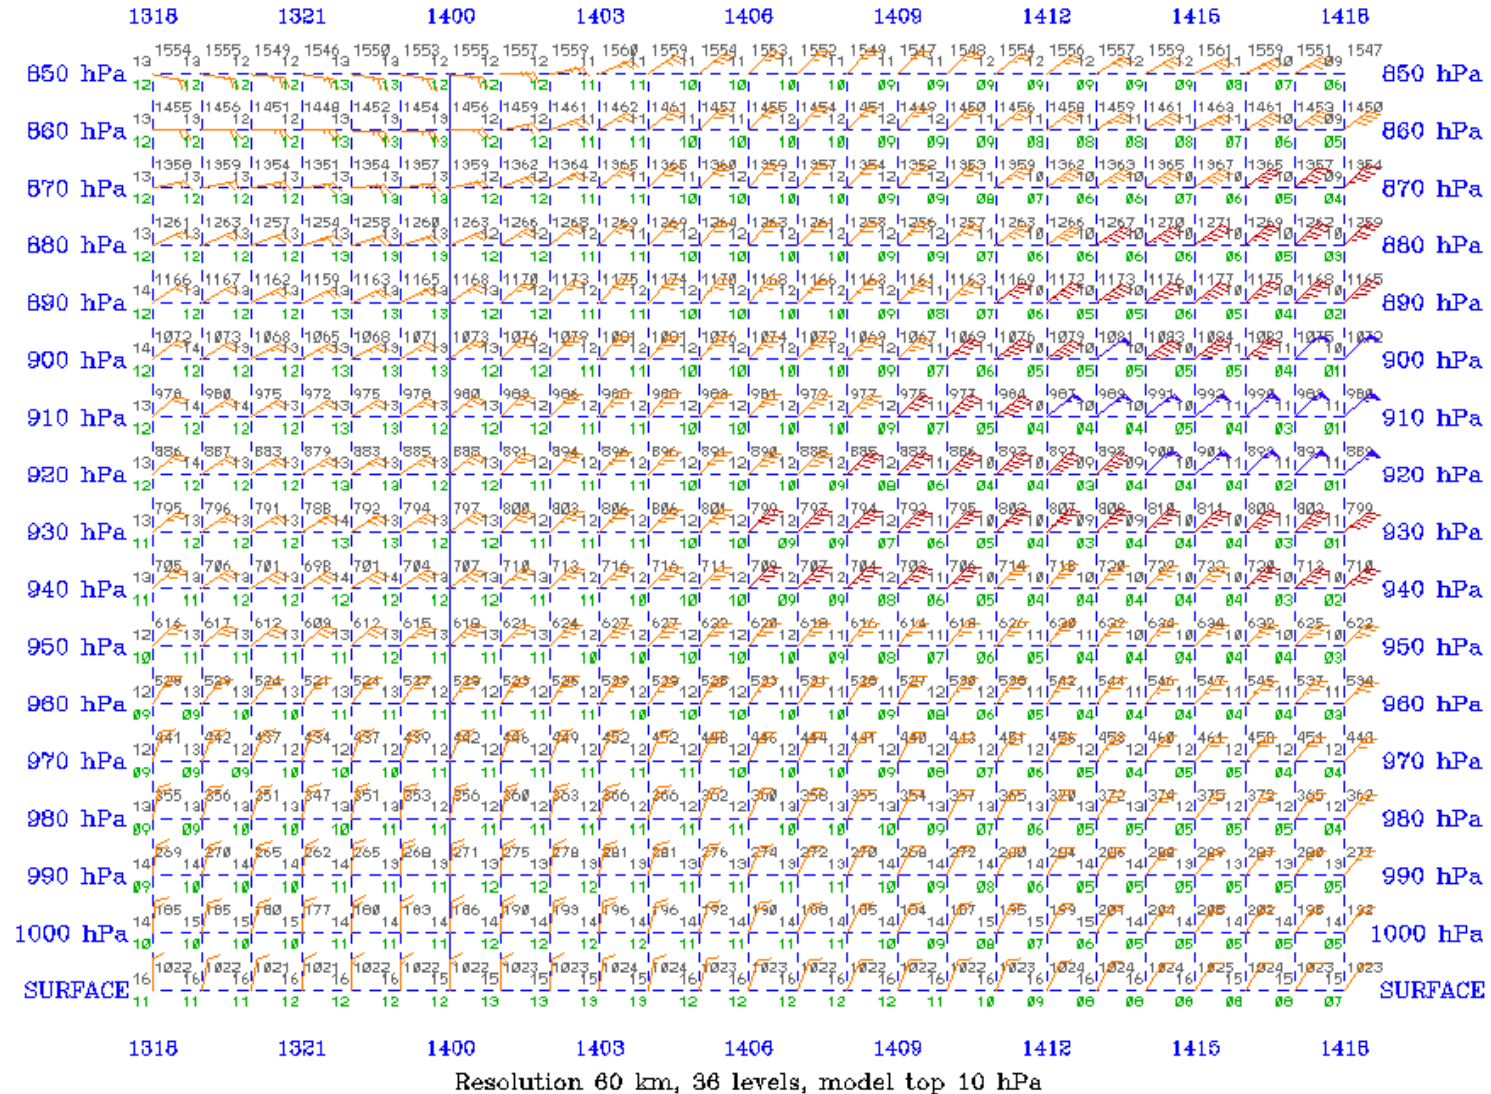
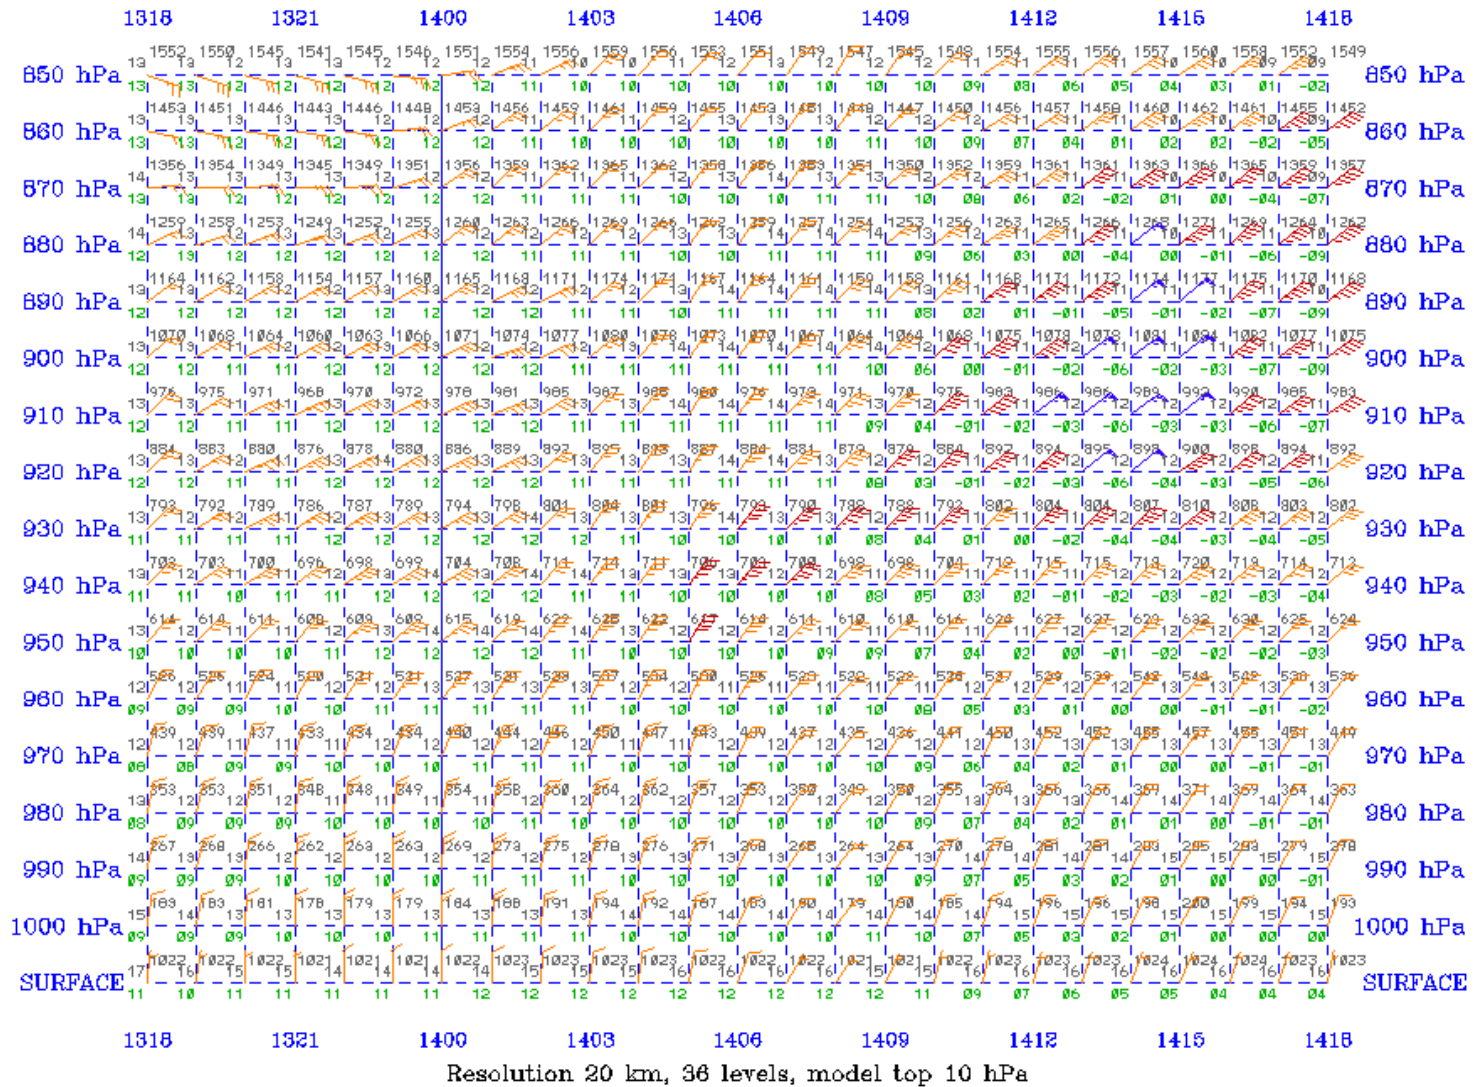
Figure 17(a). RSM Forecast Time Cross Section at HK grid
 (9812 1318 - 9812 1418 UTC)

Figure 17(b). RSM Forecast Time Cross Section at HK grid
 (9812 1318 - 9812 1418 UTC)

Fig. 17(a) and 17(b) show the time cross-section of the 60-km and 20-km model run initialized at 18Z 13 December 1998. Both runs successfully captured the strengthening of winds to 40 kts at 940 hPa at around 06Z on 14 December 1998, providing more than 6 hours of early warning to forecasters that a low-level jet would affect Hong Kong. The winds at Sha Lo Wan and Kings Park, however, had a more northerly component than the winds forecast by the model.
